Maintenance and Management of Gravel Roads

Matt Ulberg, PE

Director, Montana LTAP

Western Transportation Institute

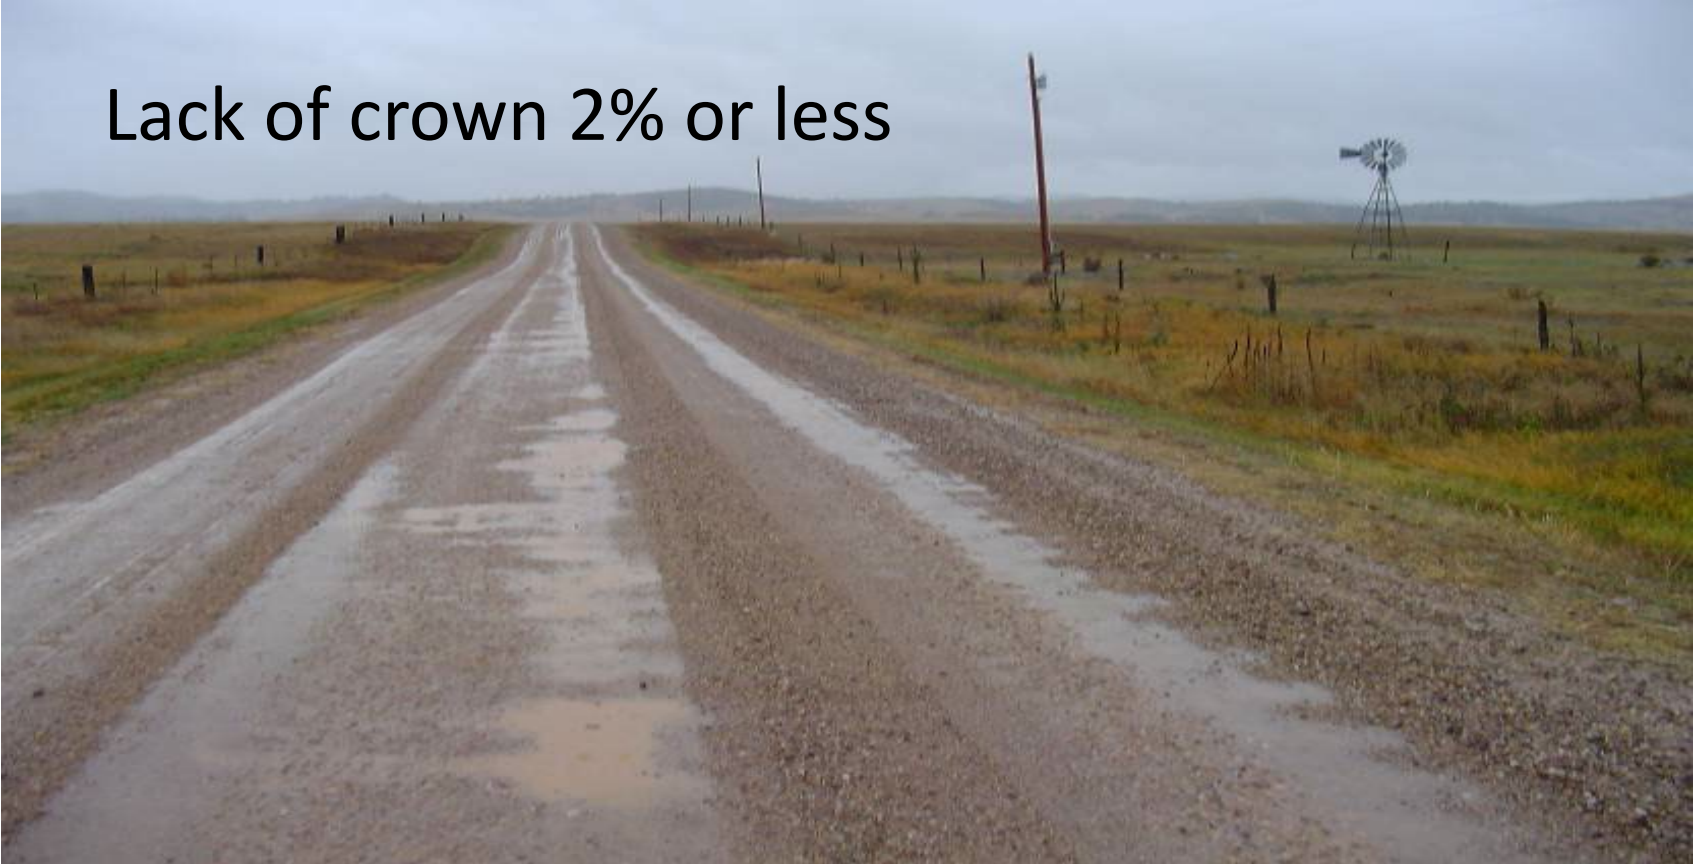
Lack of crown 2% or less

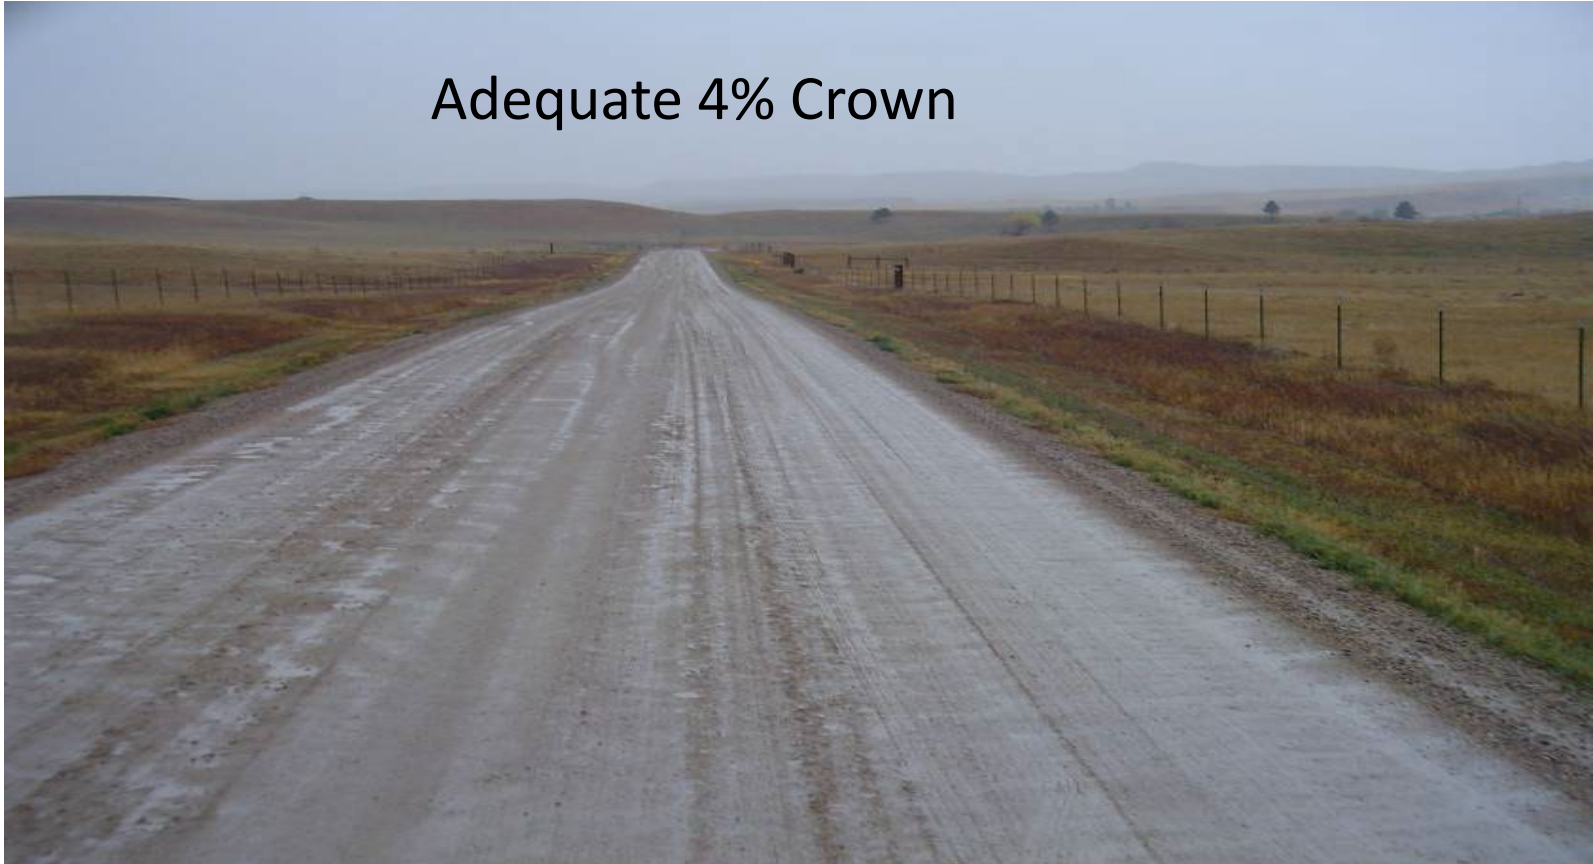
Adequate 4% Crown

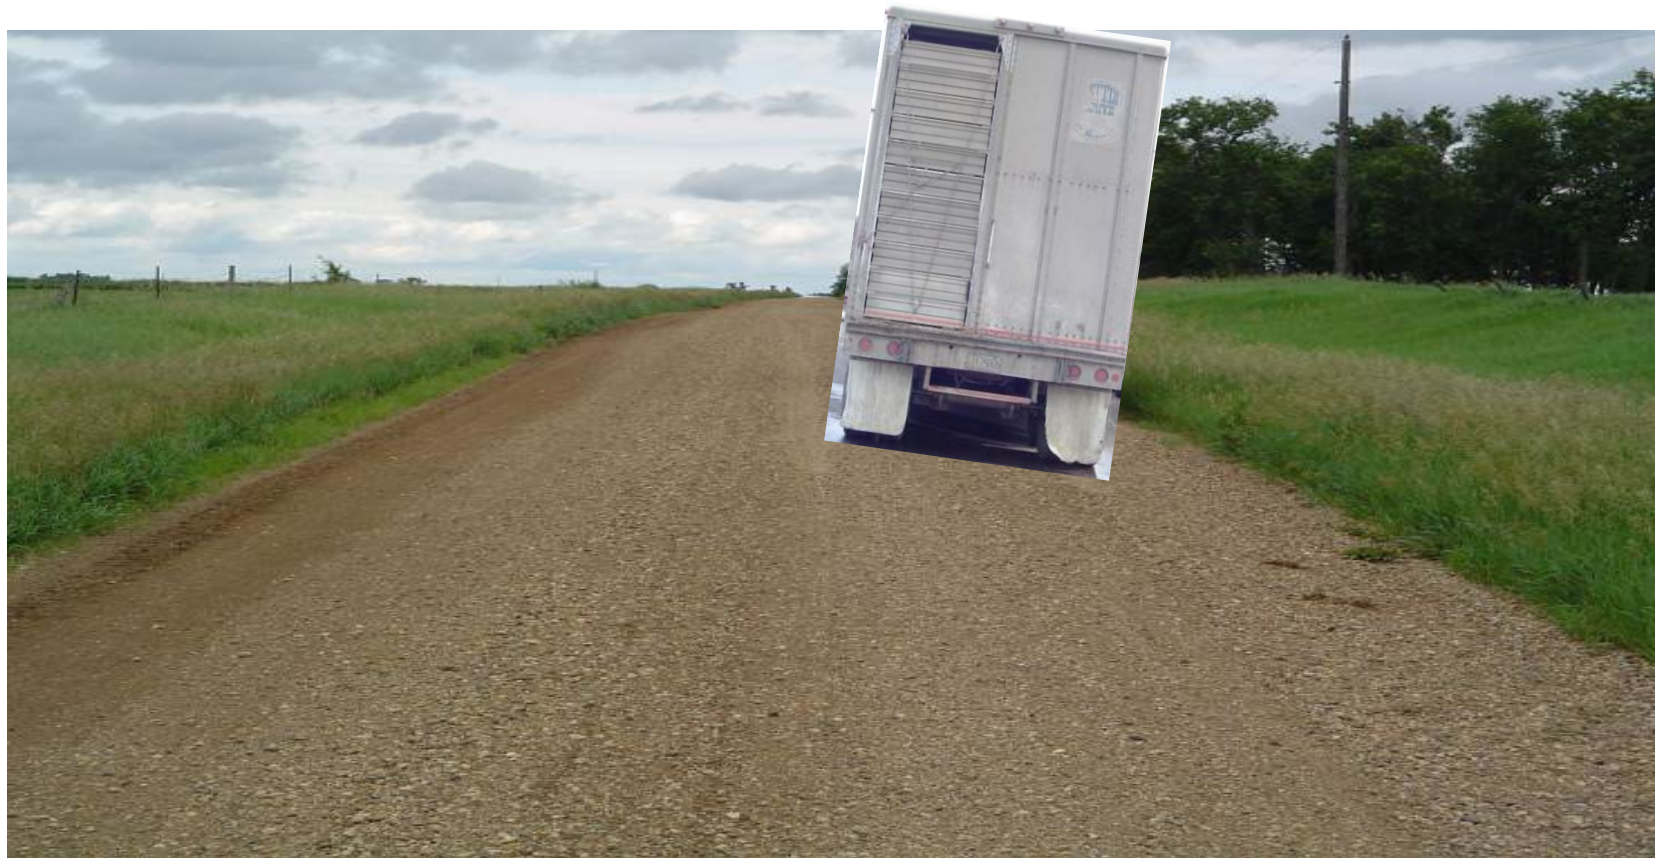
Some roads have too little crown, this one has too much.

Imagine a cattle trailer on this road.

About 13 inches on a 20' top

Too much crown tend to force traffic to drive in the middle of the road!

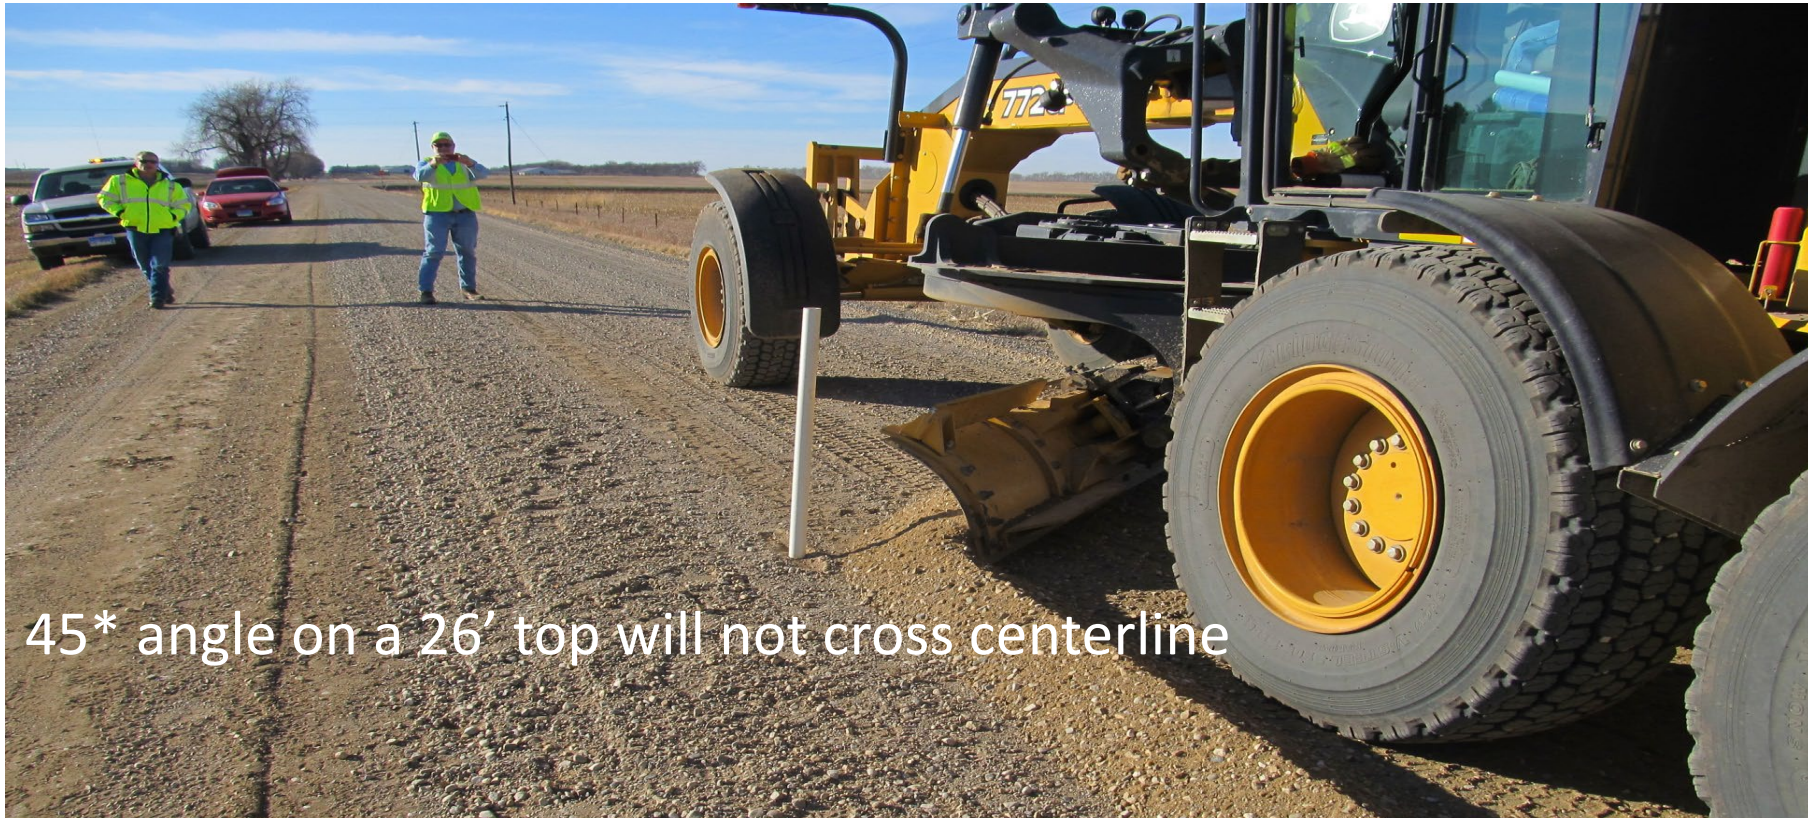
Moldboard Angle

45* angle on a 26' top will not cross centerline

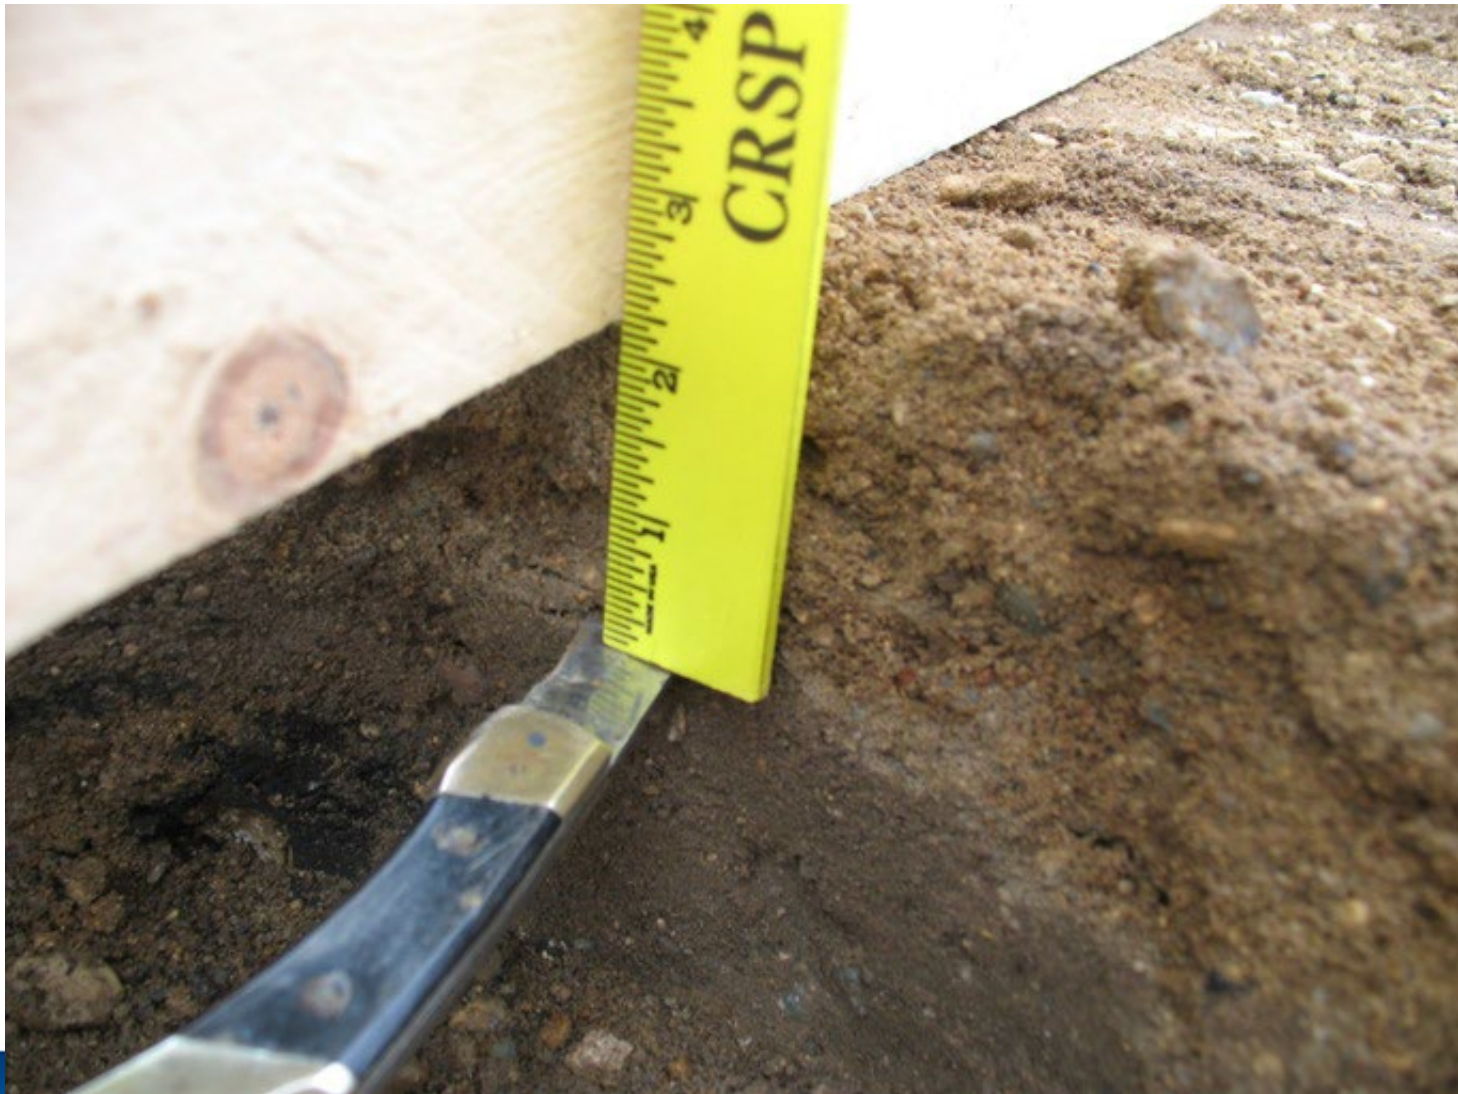
Over two inches of thickness deviation

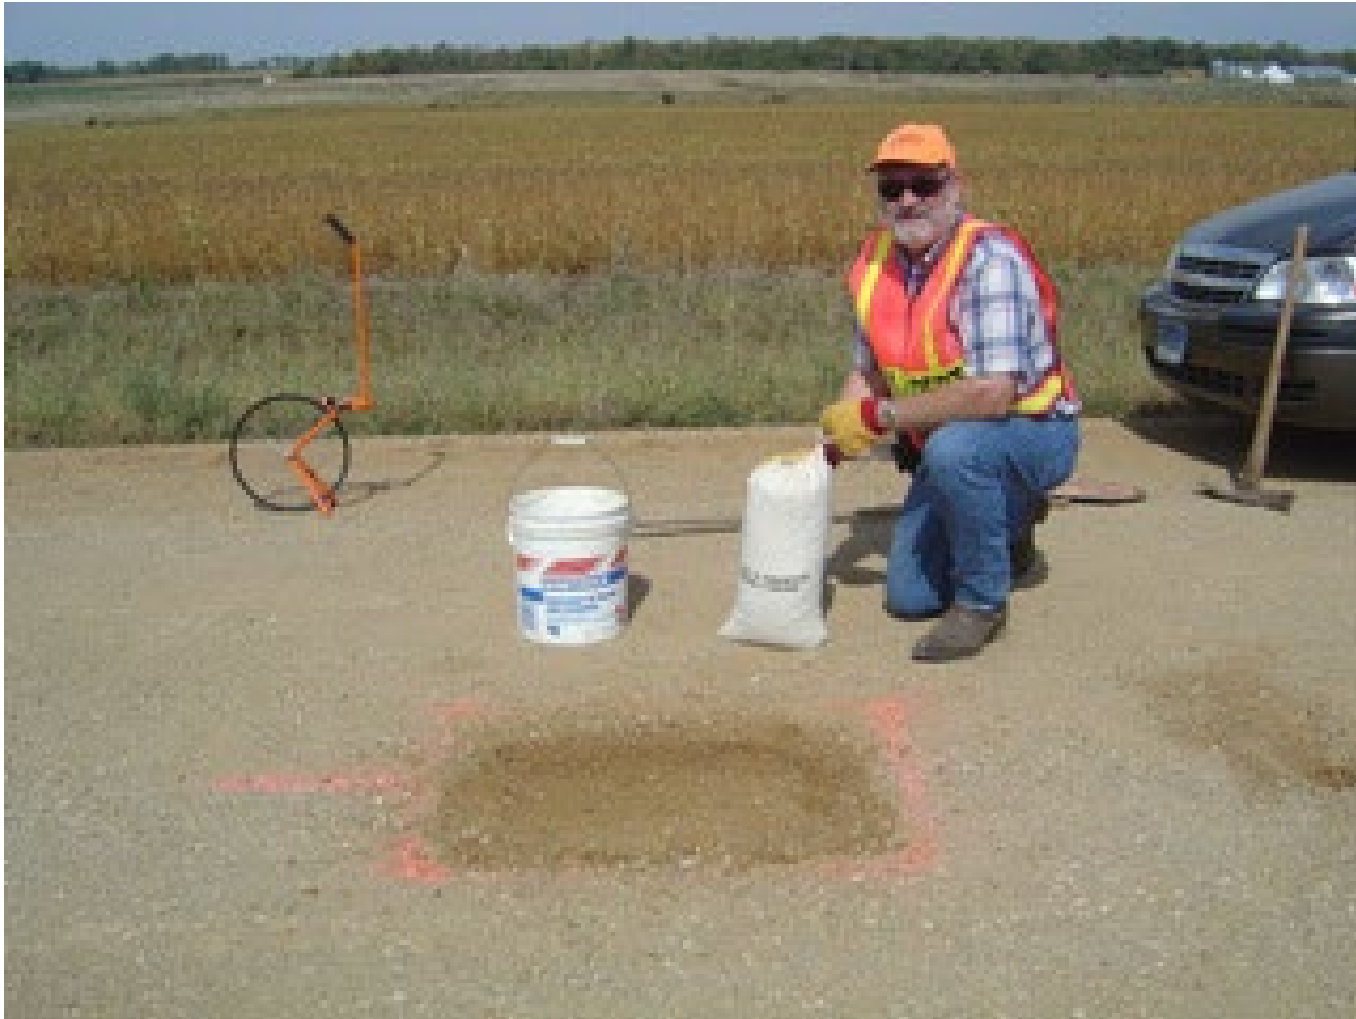
Example of test pit in existing gravel road

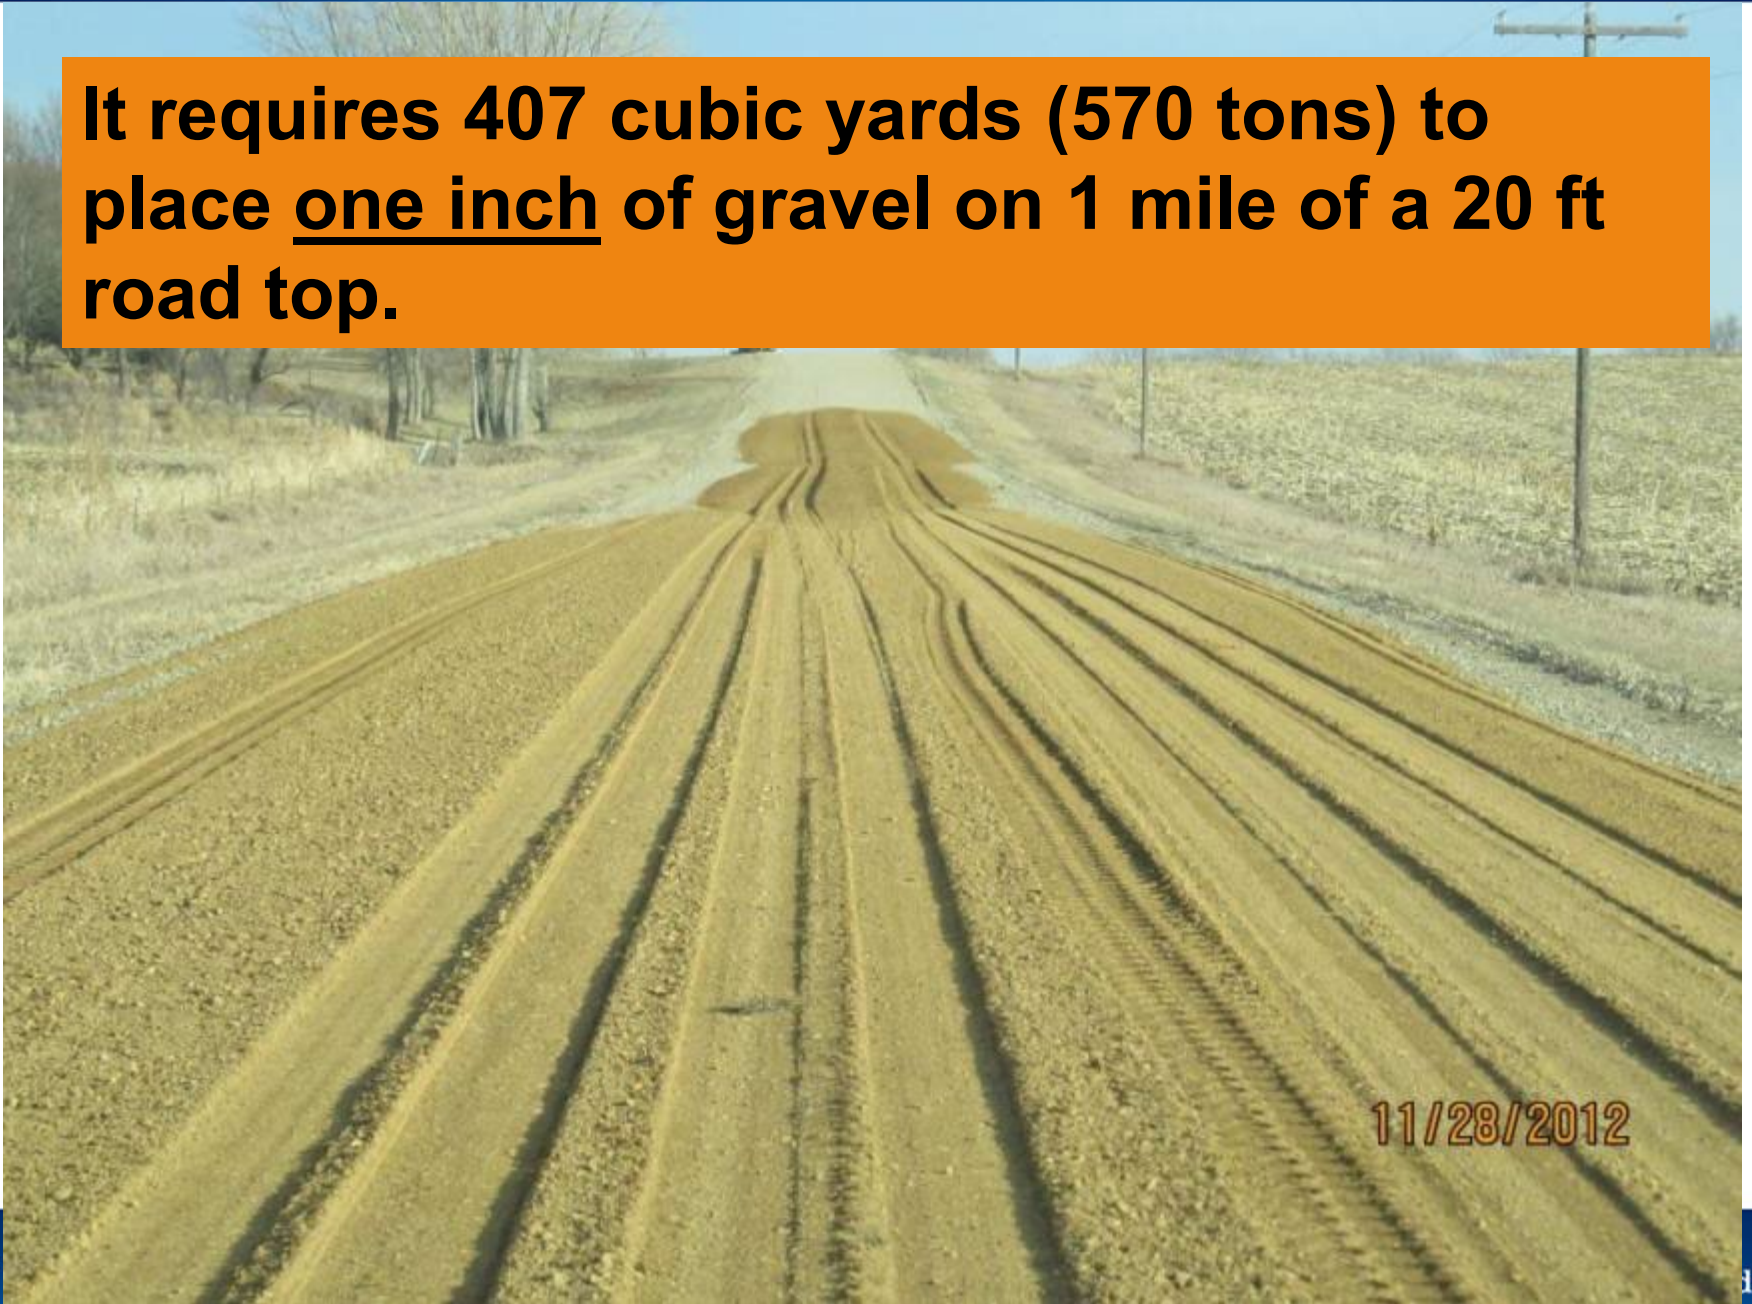
It requires 407 cubic yards (570 tons) to place one inch of gravel on 1 mile of a 20 ft road top.

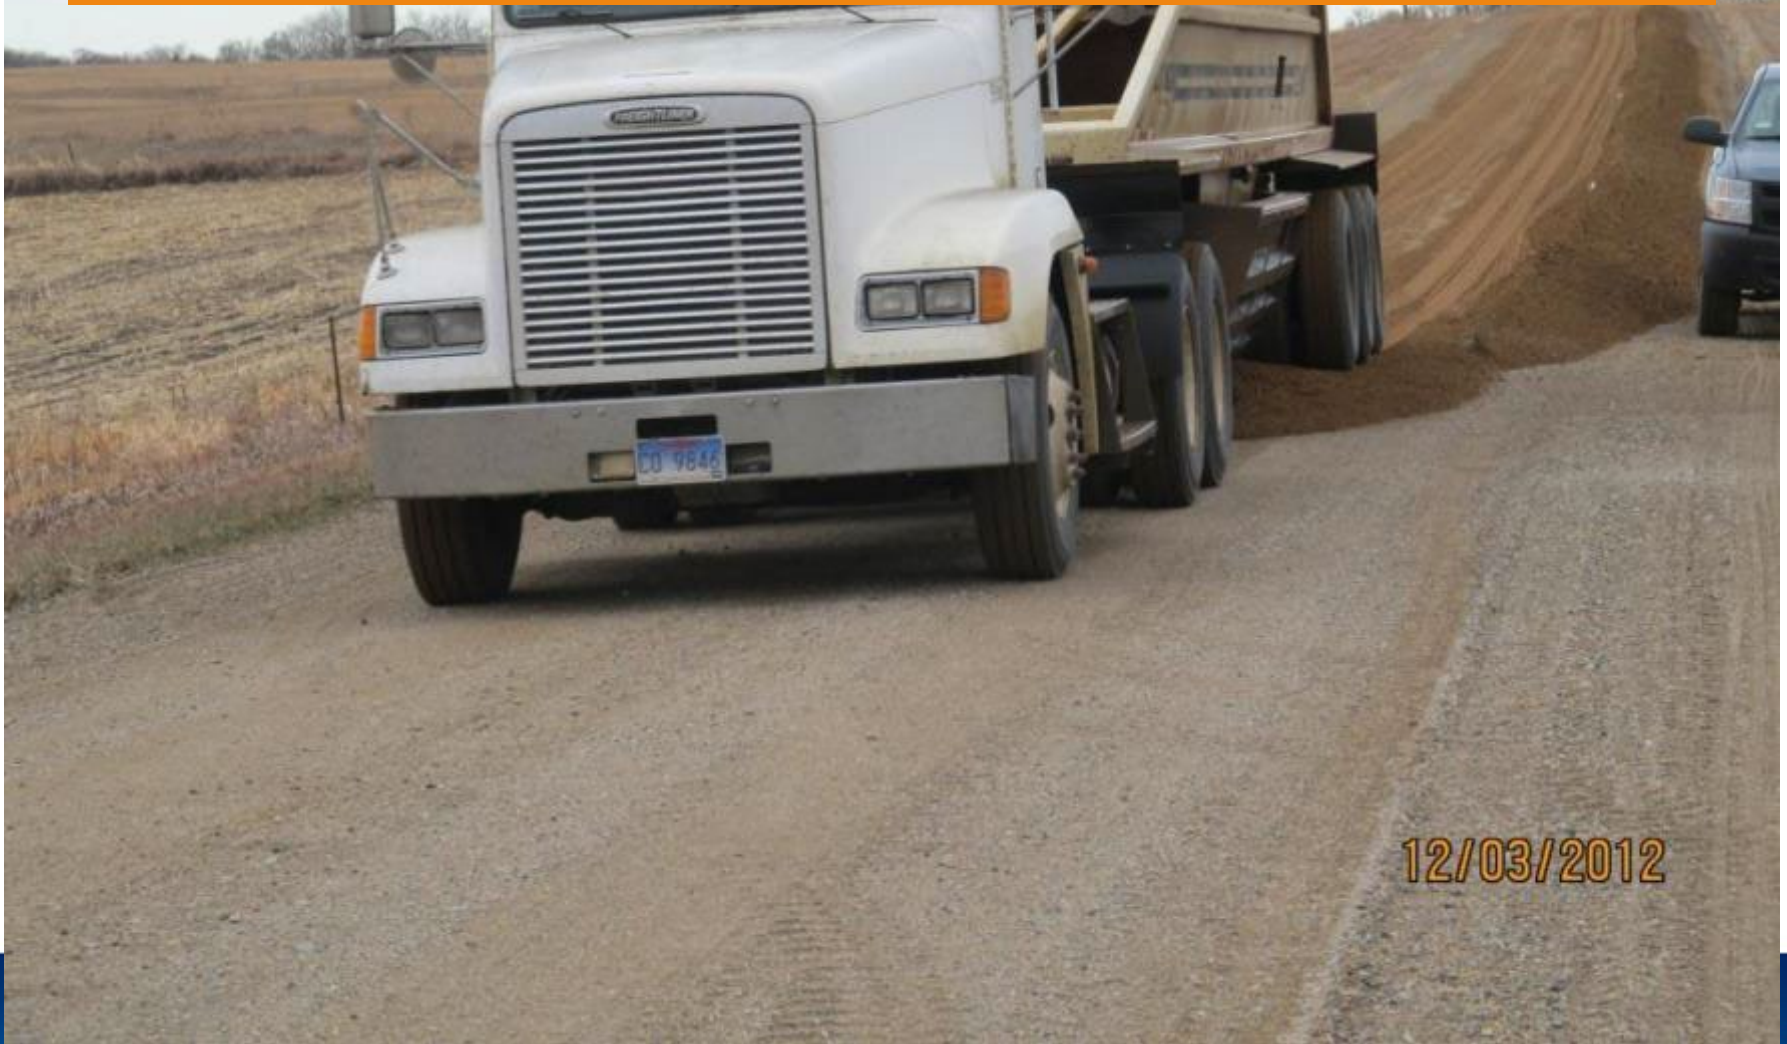
A 25-ton load of gravel covers only 320 linear ft to place one inch of gravel on a 20 ft road top.

- If you are not measuring layout distances, you are NOT laying out consistent layers of gravel.
- Do you have another way? Teach me!

Note: this is an adequate layer for maintenance, but not adequate thickness to carry legal loads during spring thaw!

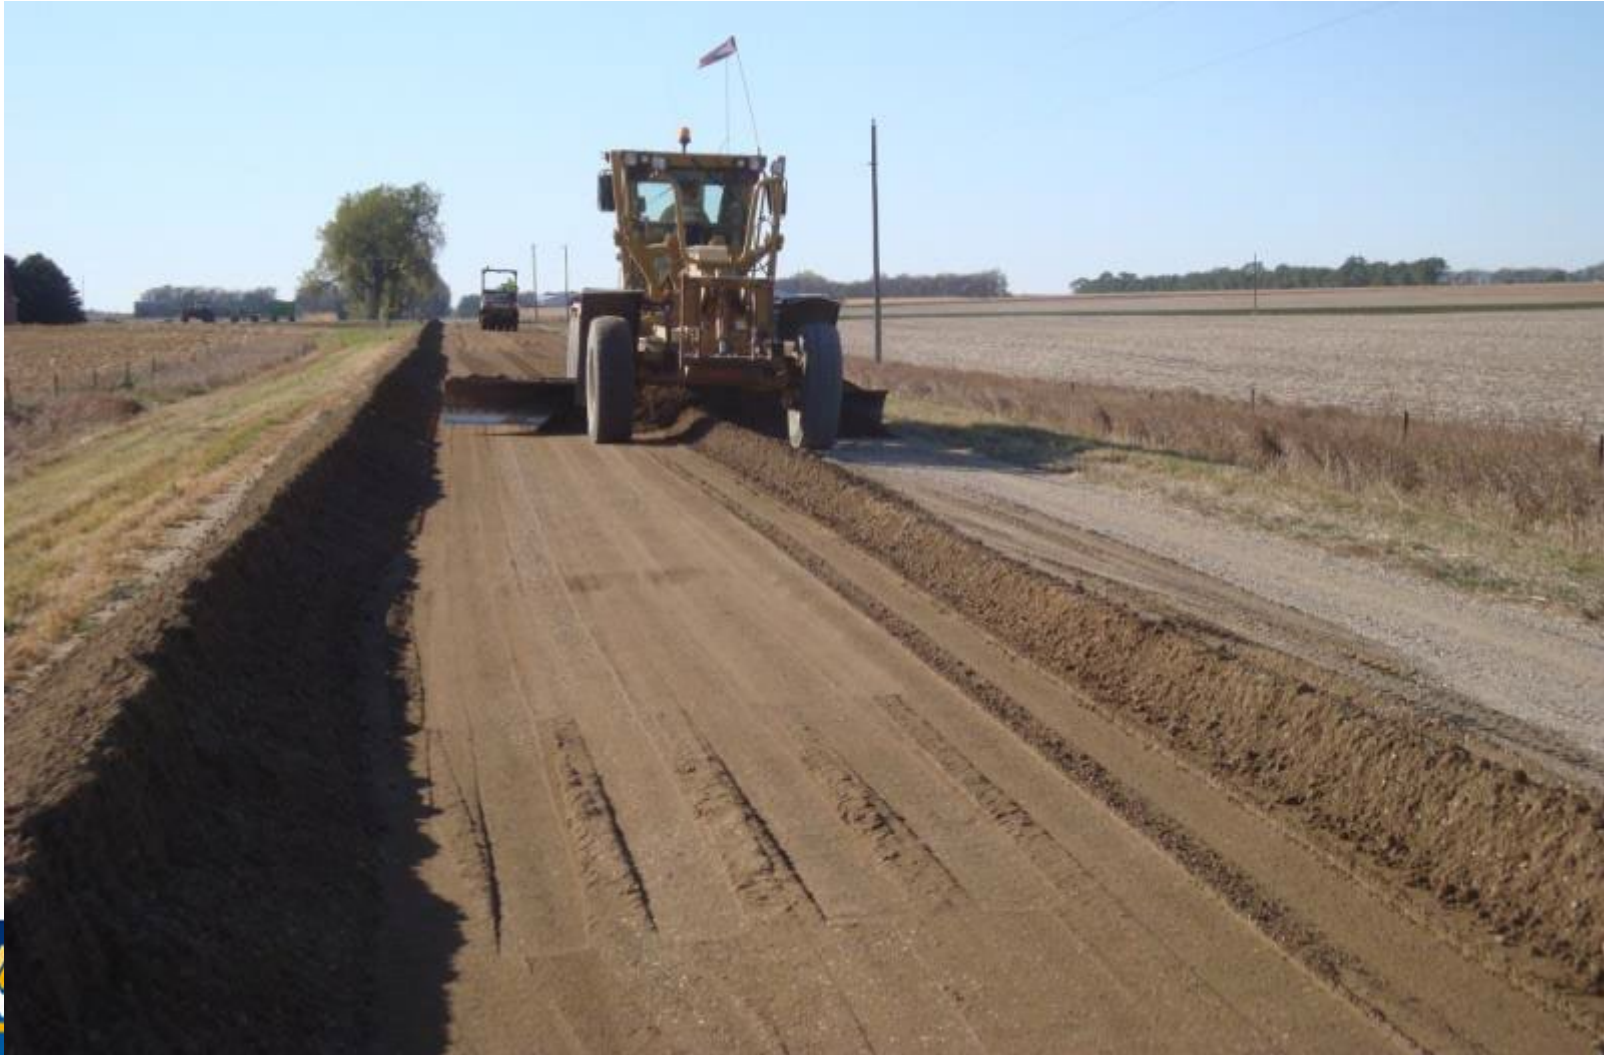
Each section was built with three to four inches of new gravel after existing surface was prepared and shaped. Compaction/non compaction comparison as well.

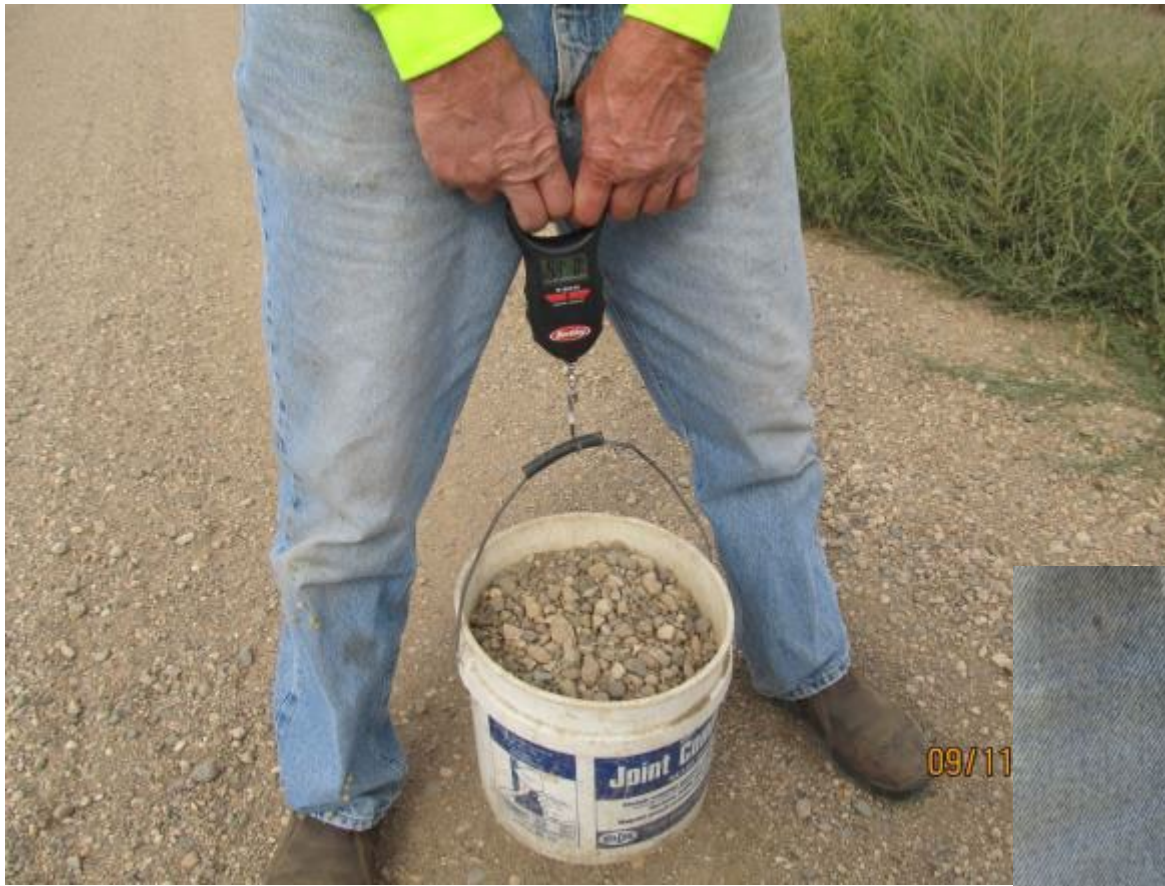
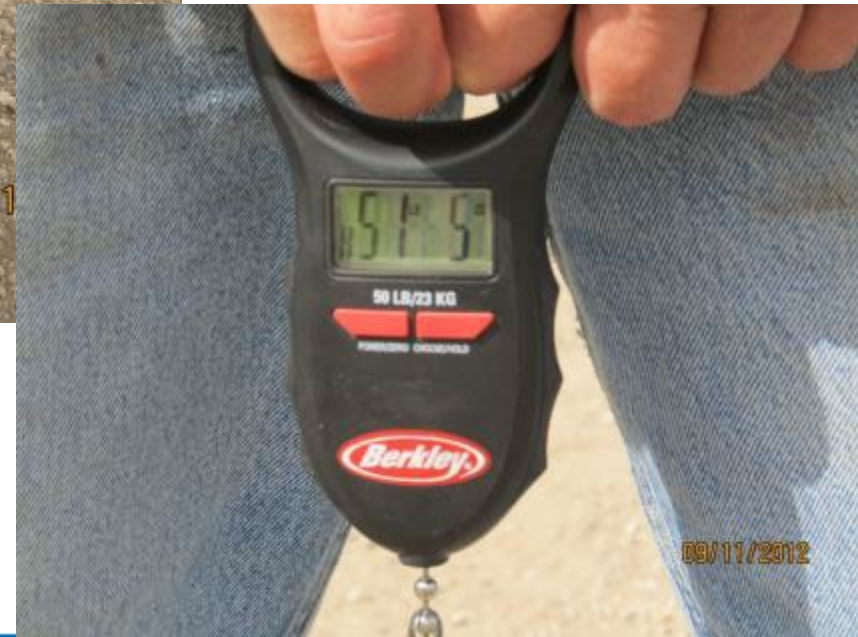
Simply remove loose aggregate from a 10 inch cross section, weigh it and convert that to a one-mile section

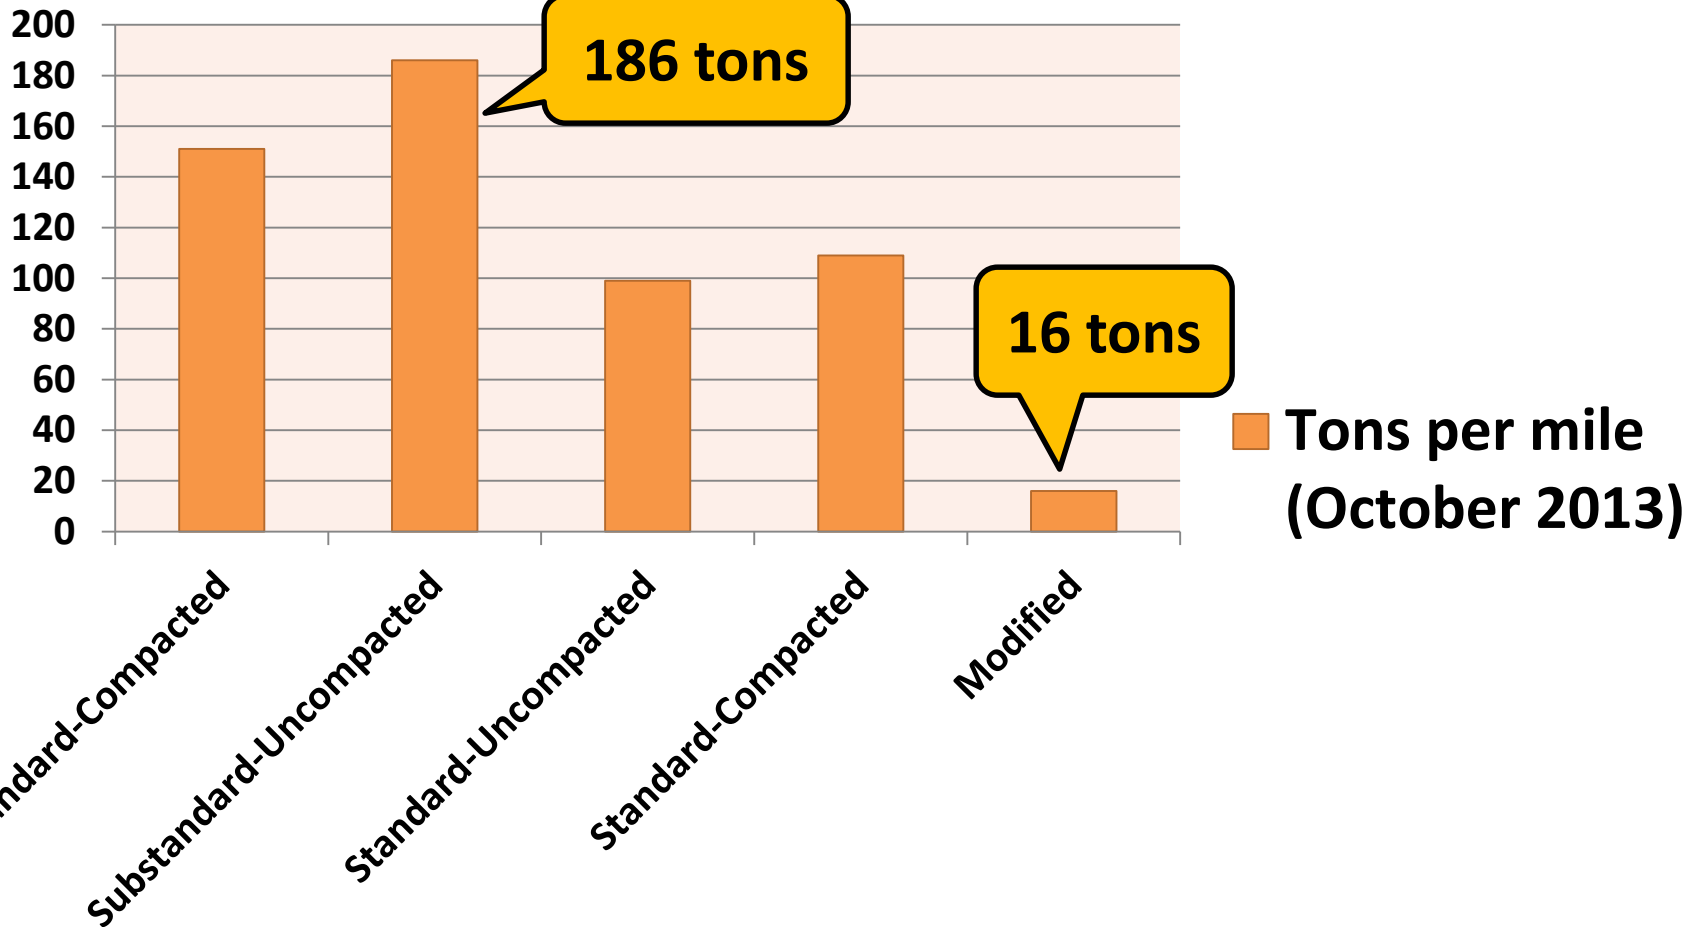
Brooking Section – Loose aggregate 2013

Tons per mile (October 2013)

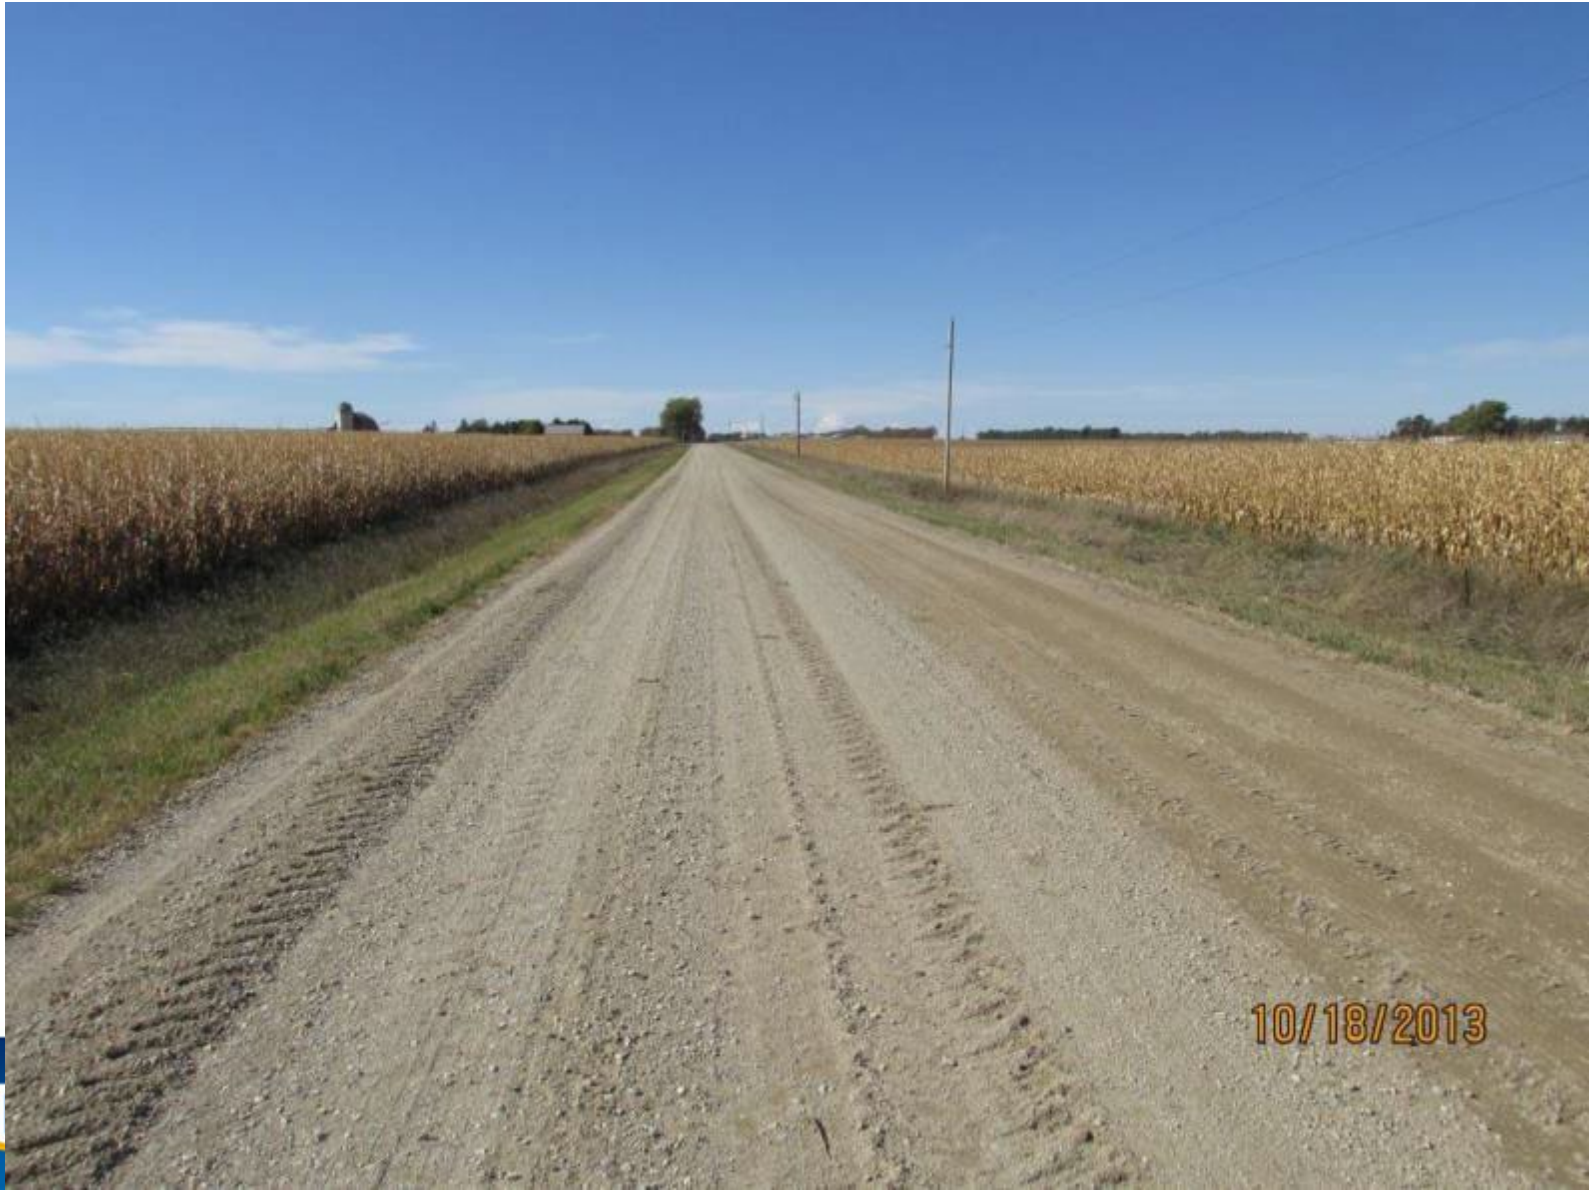
Substandard section – aggregate has moved outward over 4 ft since construction

View of Substandard section – 10-18-13

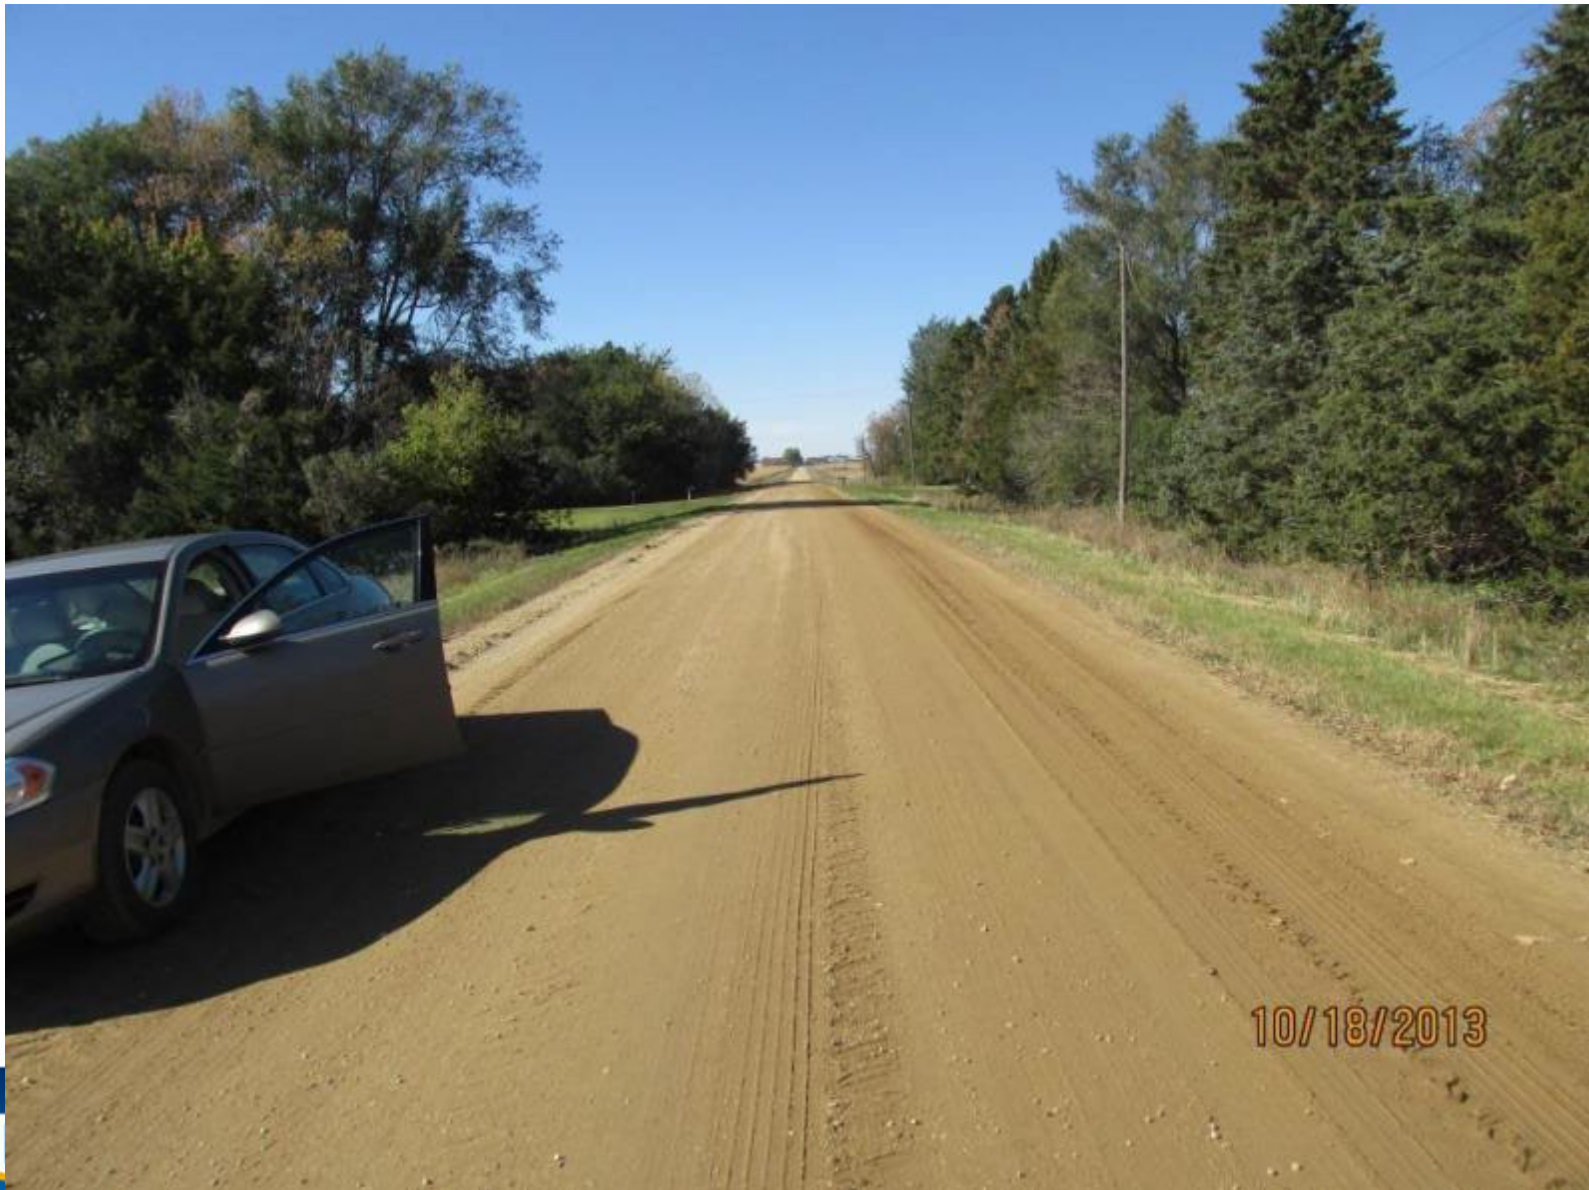
Modified section has moved outward only six inches since construction

View of Modified section – 10-18-13
