Maintenance and Management of Gravel Roads

Matt Ulberg, PE

Director, Montana LTAP

Western Transportation Institute

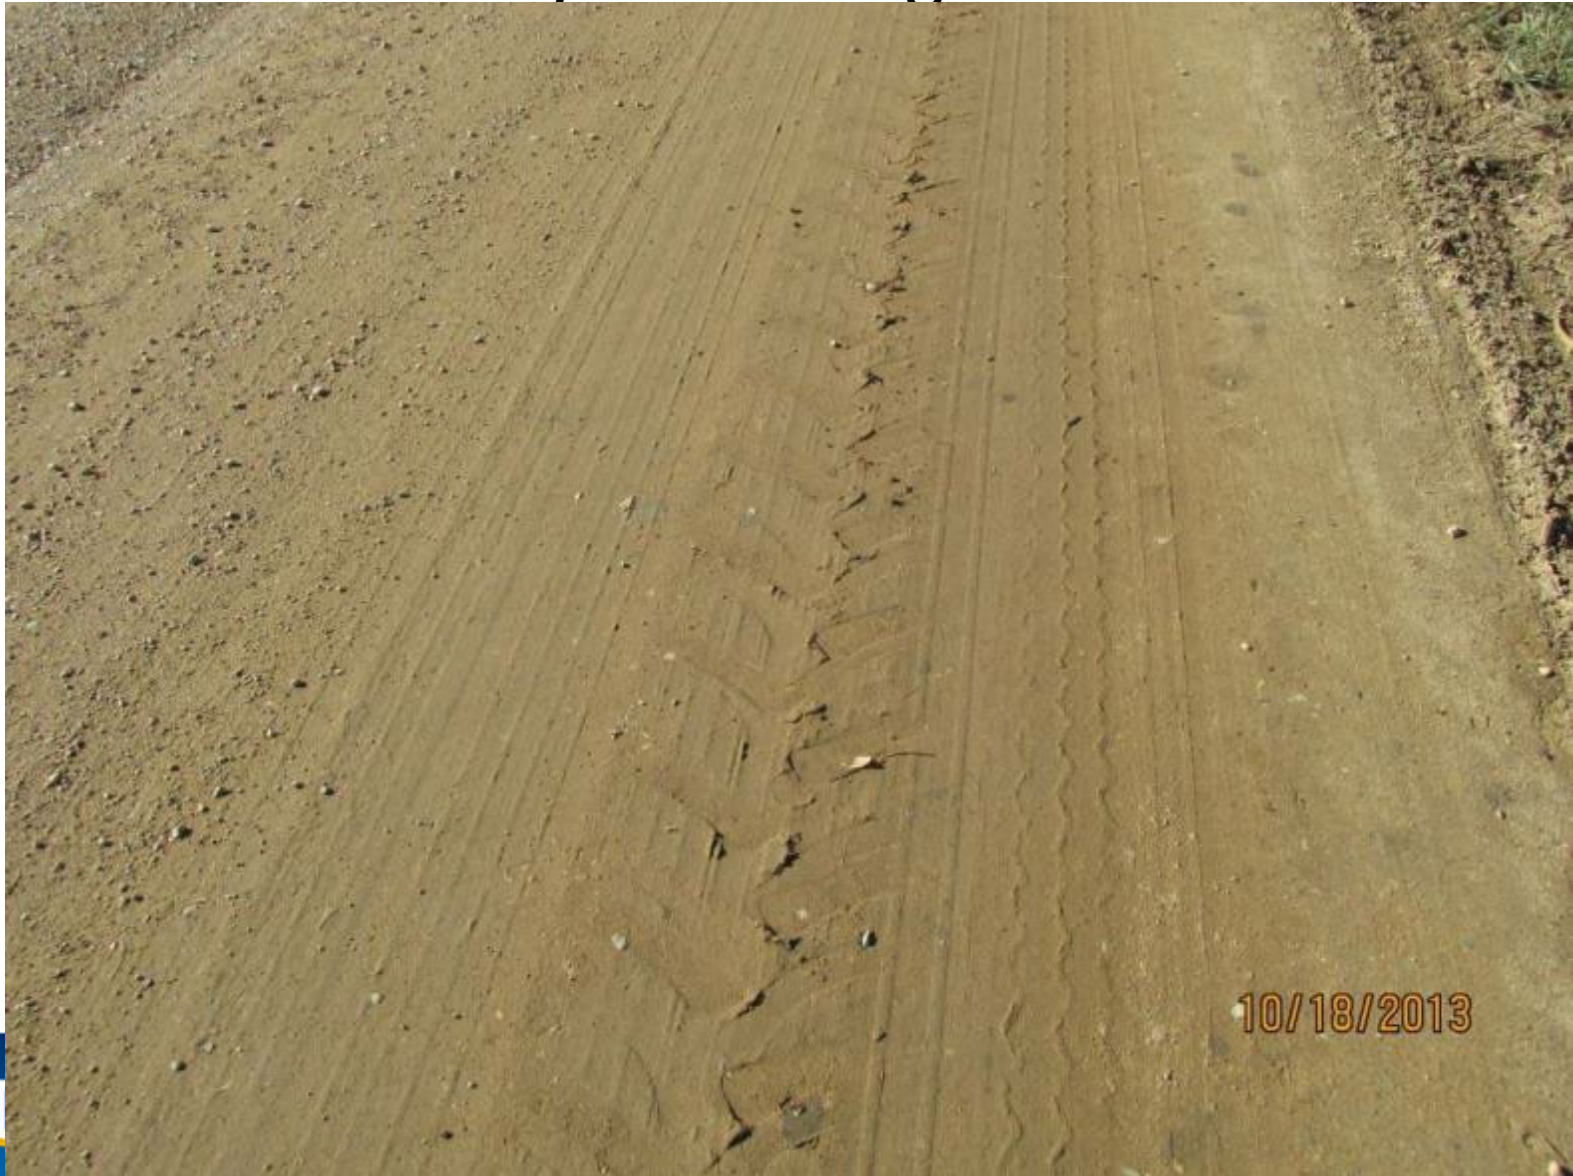
Does the modified section rut in wet weather? No, virtually no rutting observed.

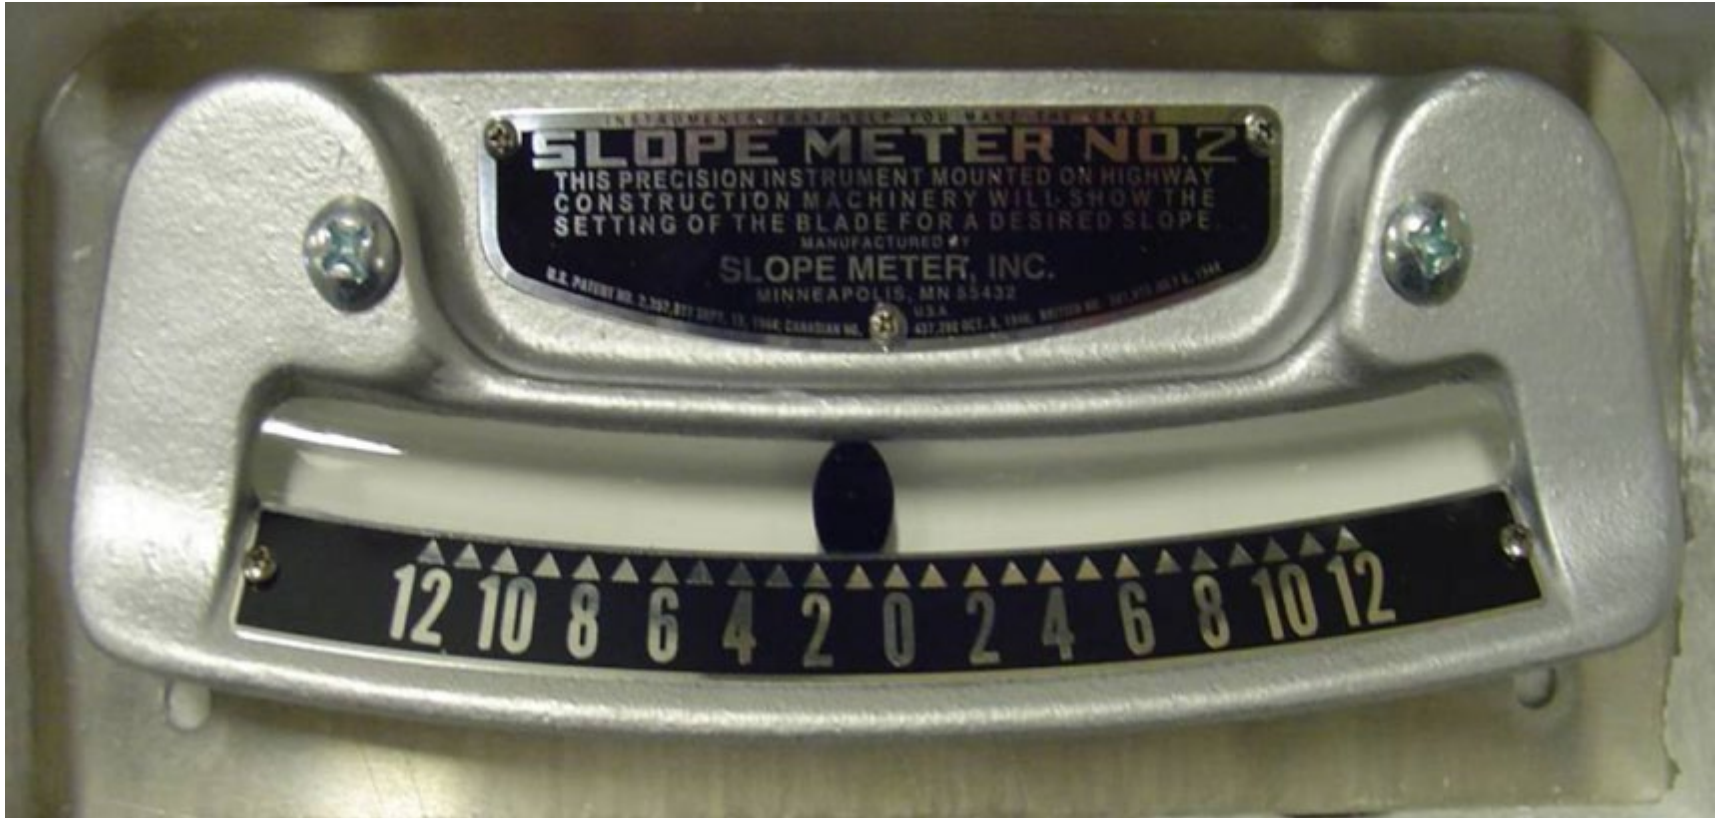
A crown gauge is helpful

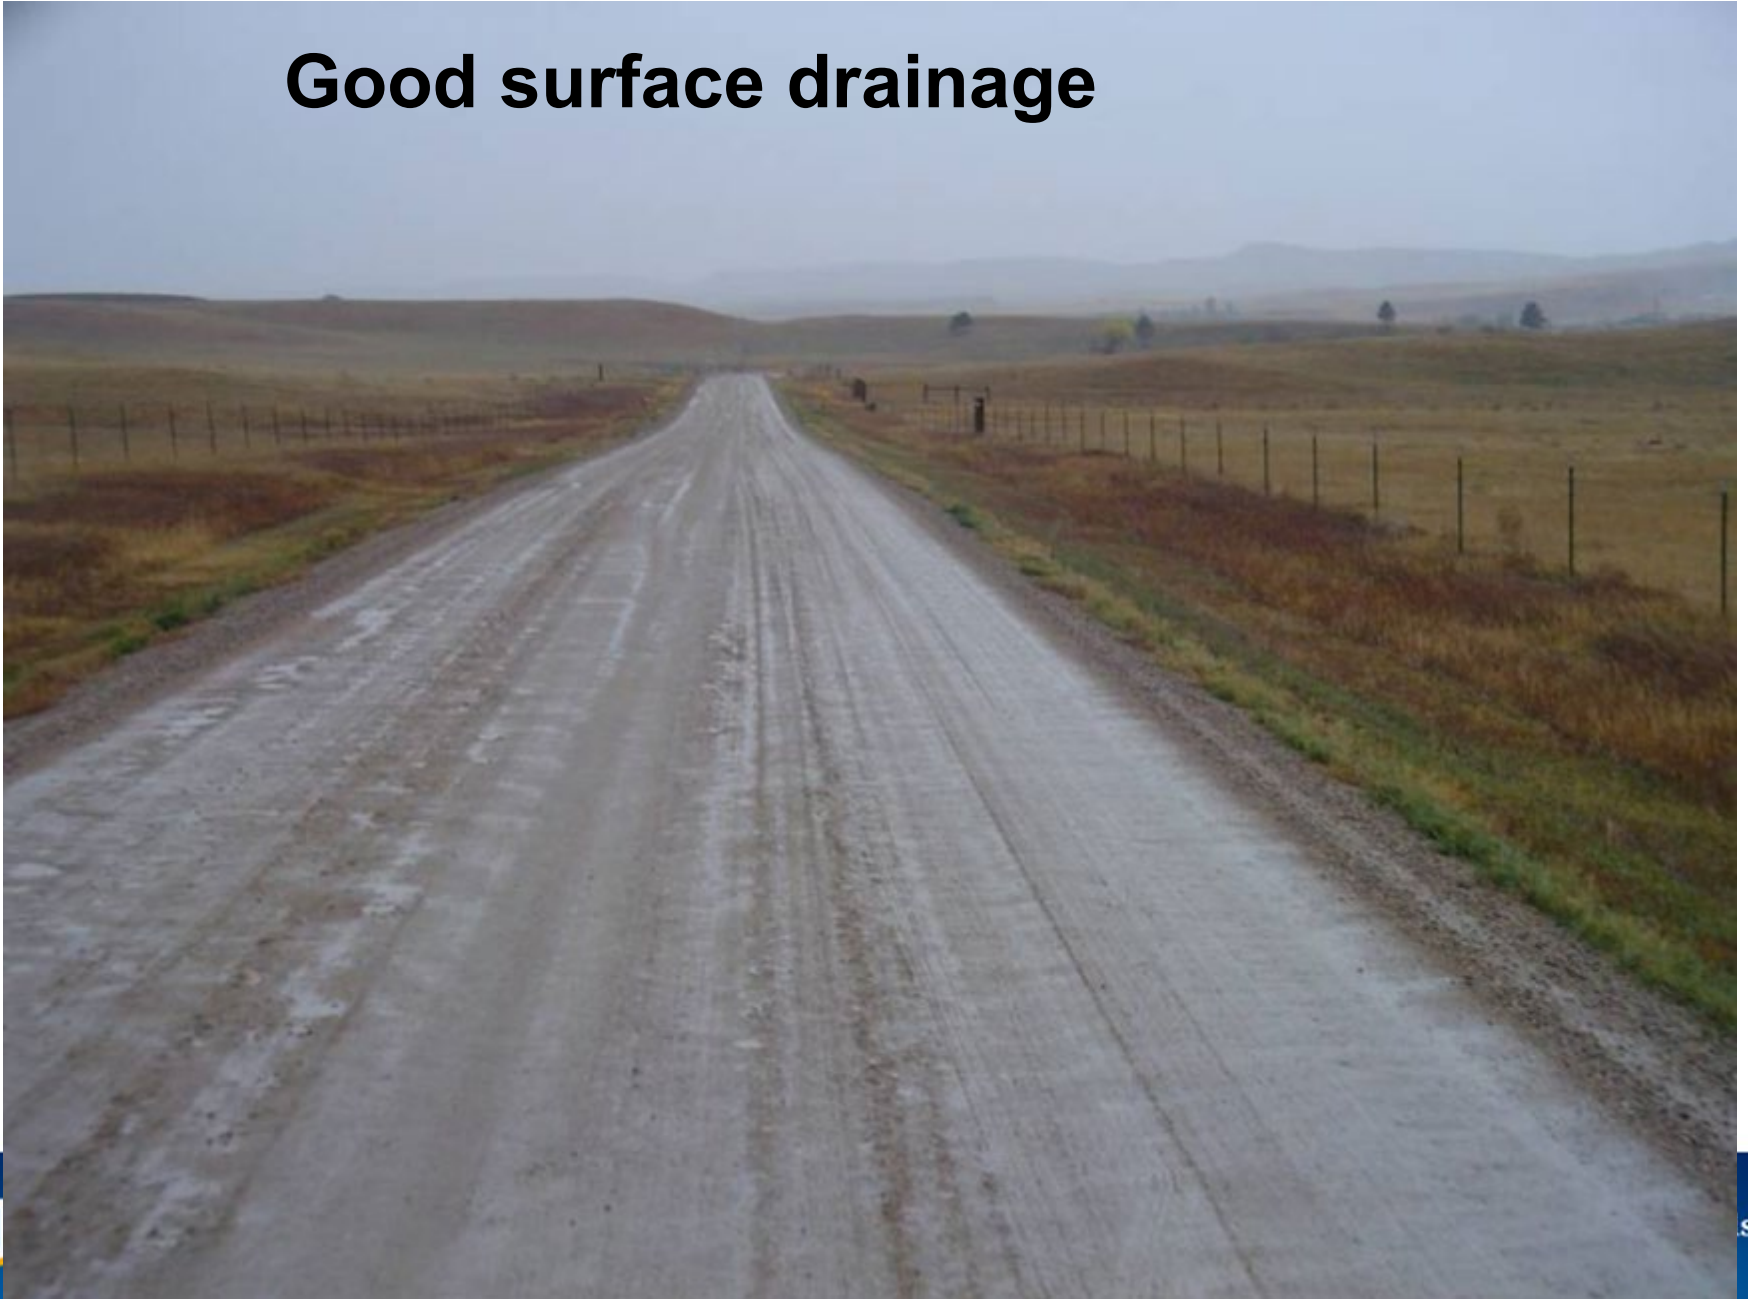
Poor surface drainage

Good surface drainage

**Crown should be near $\frac{1}{2}$ inch per ft
(4% drop on the cross slope)**

**Example: 24 ft. roadway width should have near 6
6 inches over 12 feet, 6 inches of crown per side**

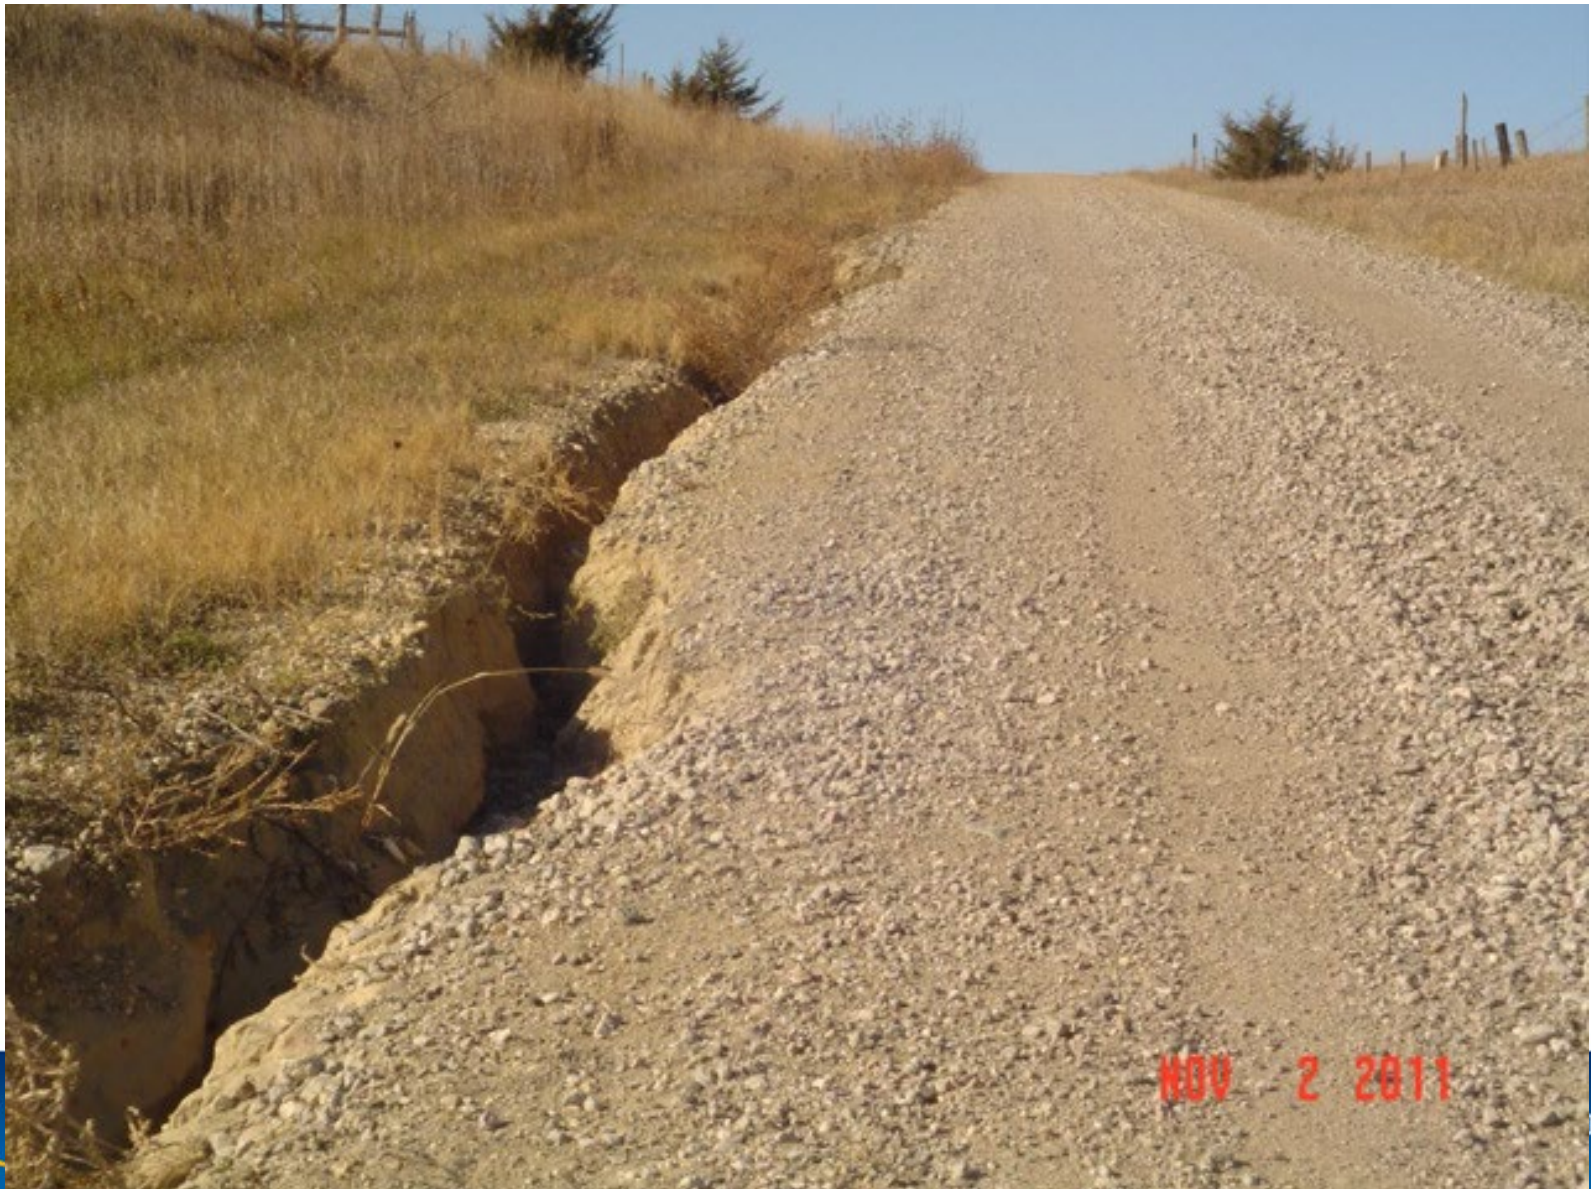
The Next Challenge – High Shoulders!

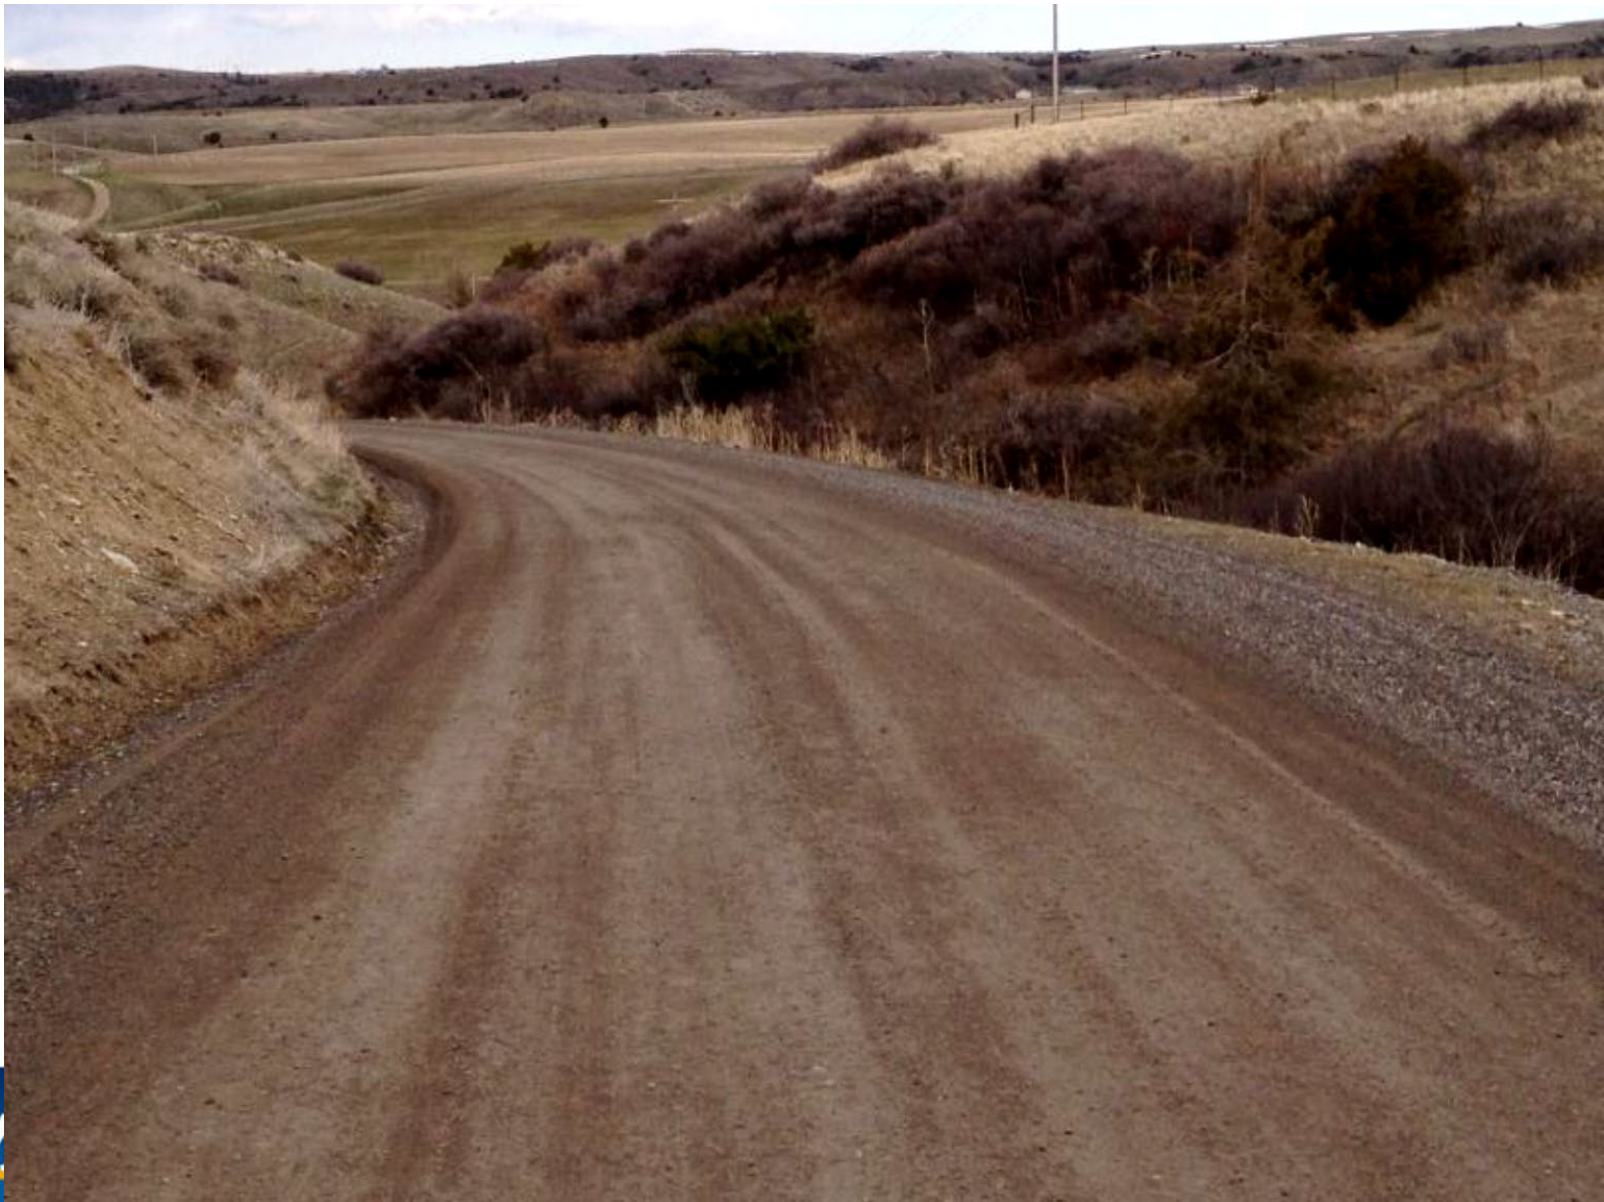
Reasonably good cross section on low volume road with poor horizontal and vertical alignment

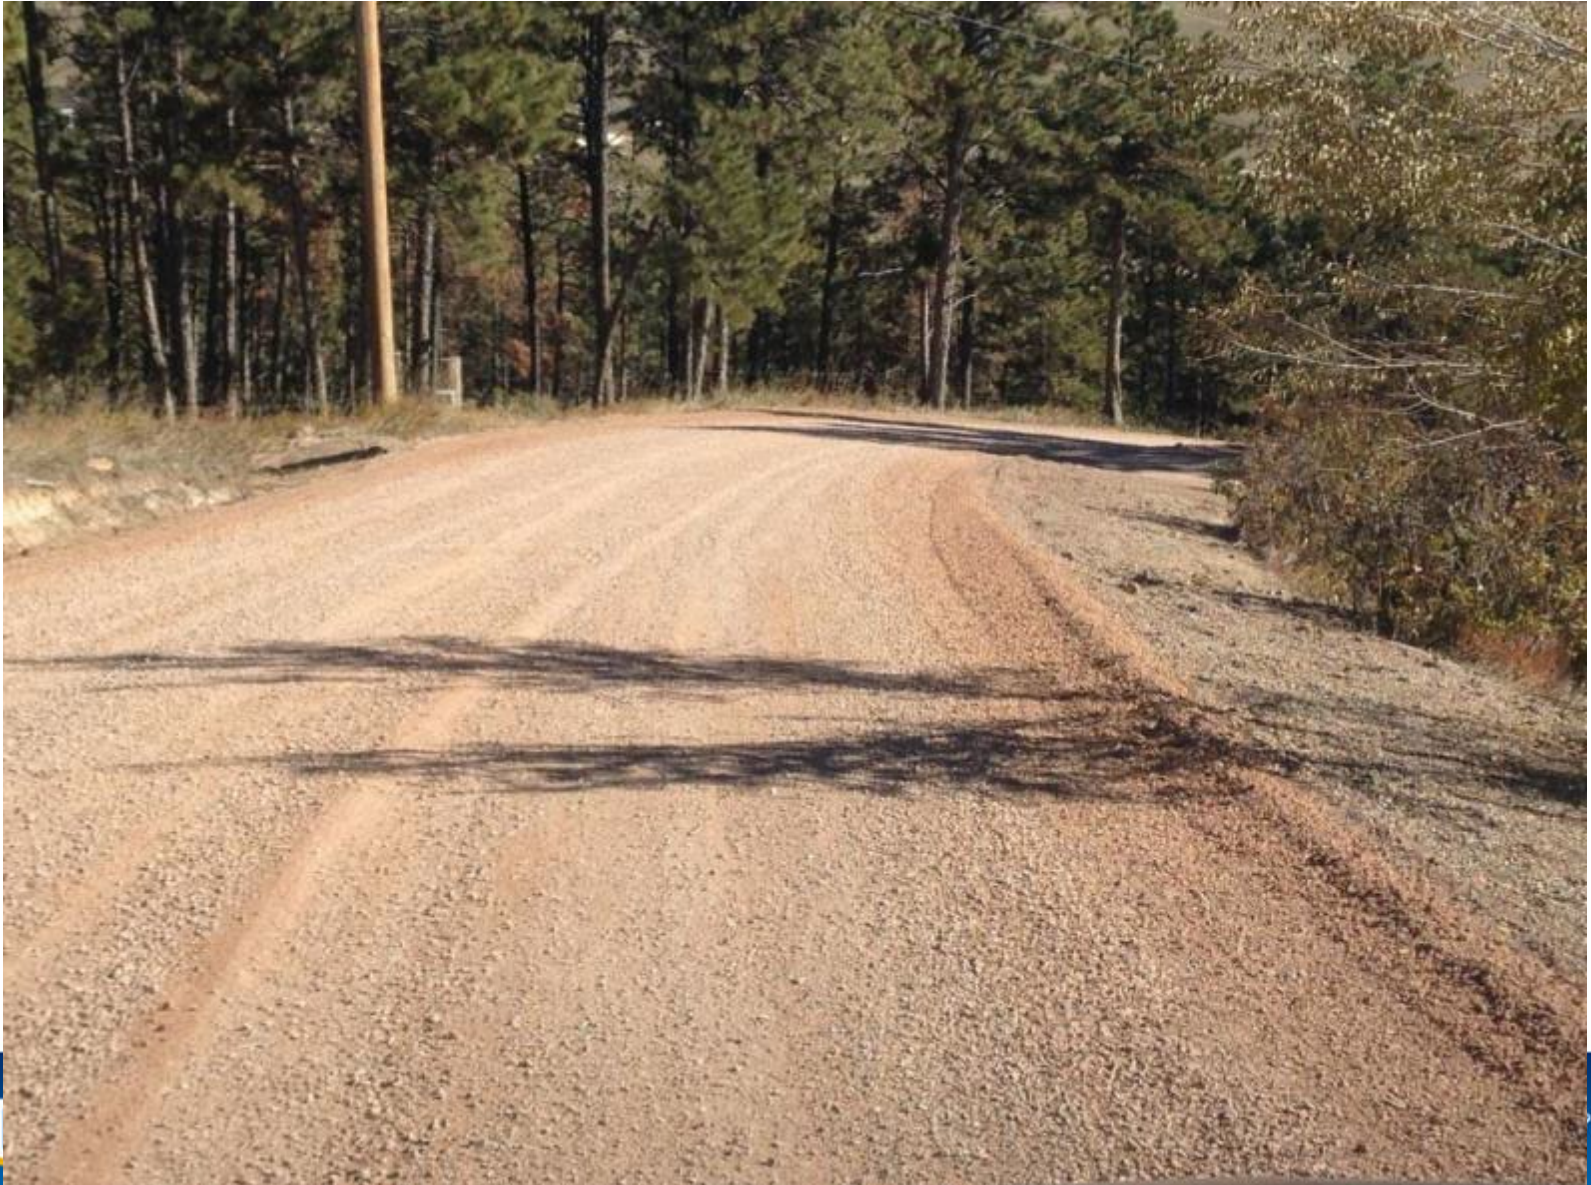
Most of the surface is tightly bound here

Surface aggregate has good overall gradation and relatively small top size.

Virtually no corrugation on day of observation

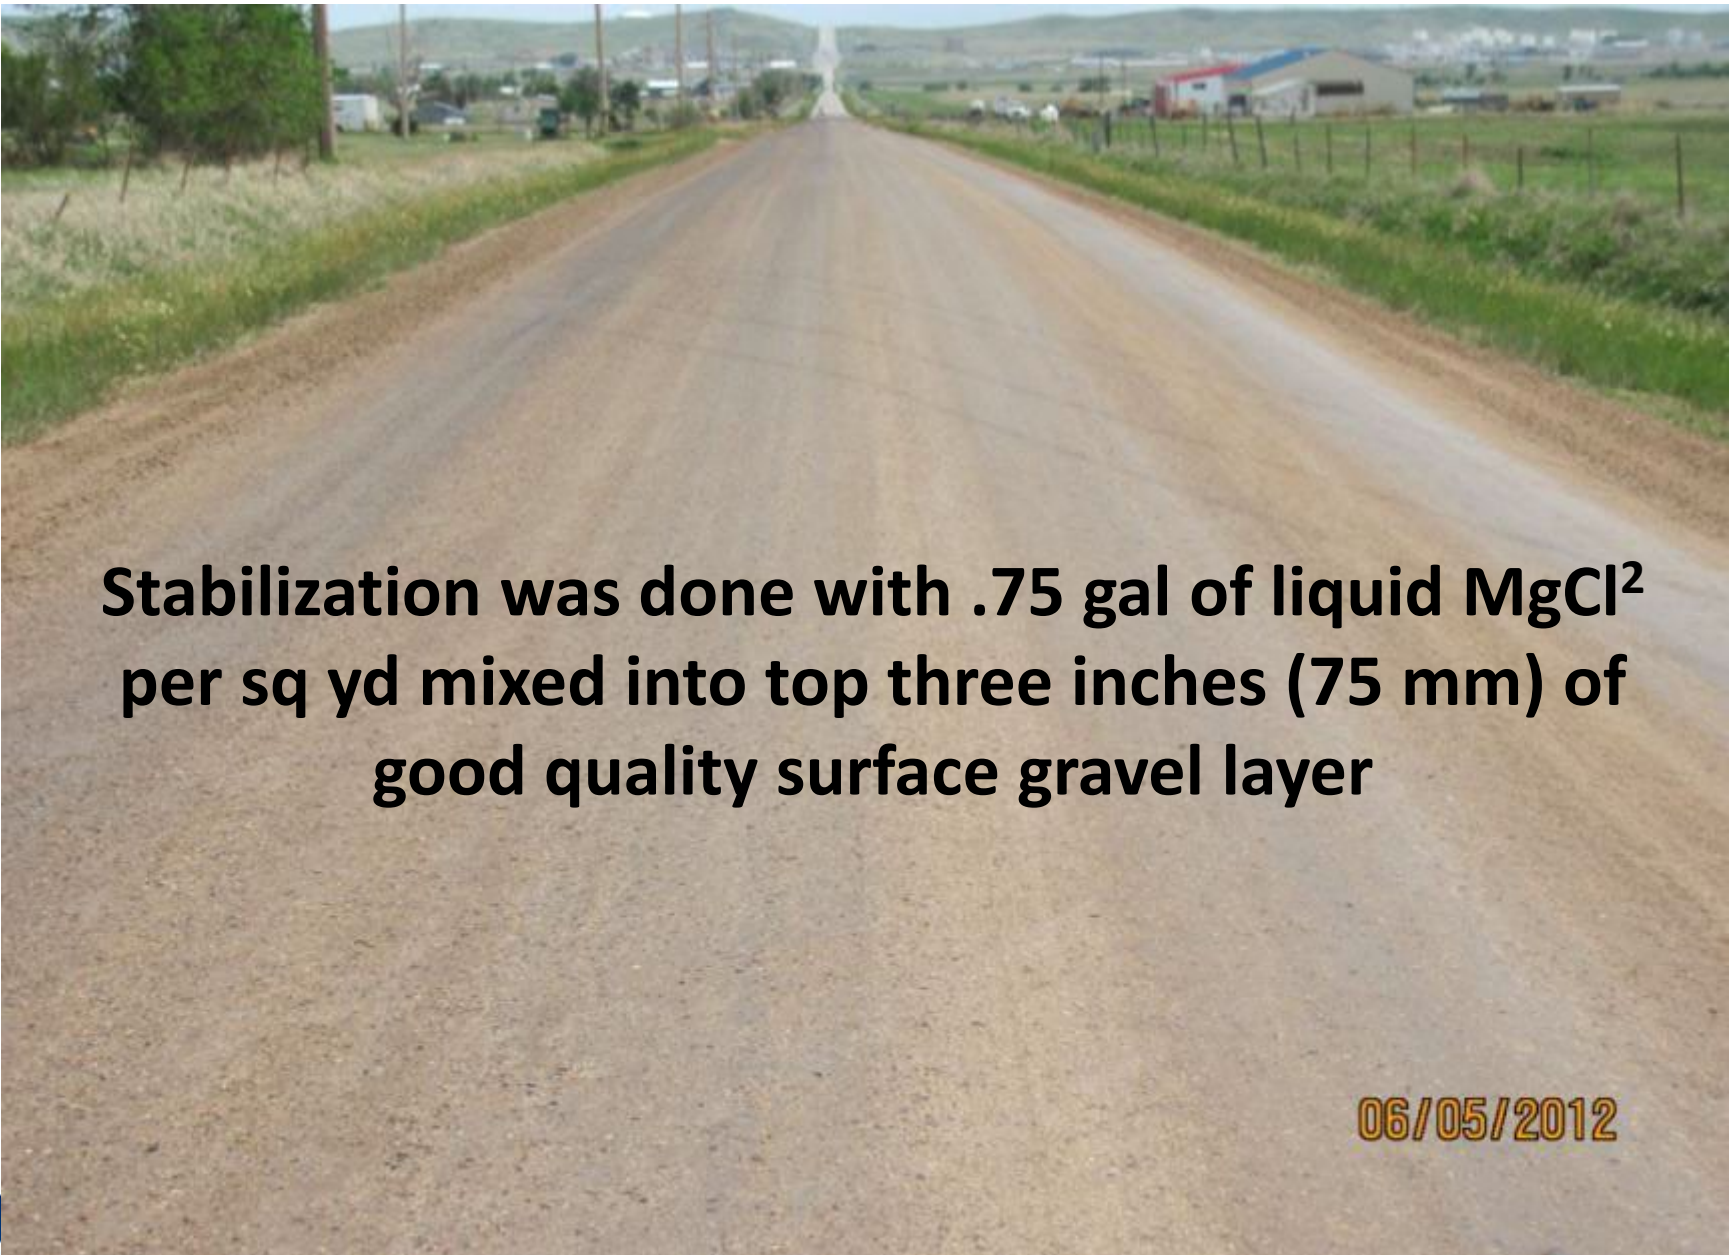
Close-up view of stabilized surface

Stabilization was done with .75 gal of liquid $MgCl^2$ per sq yd mixed into top three inches (75 mm) of good quality surface gravel layer

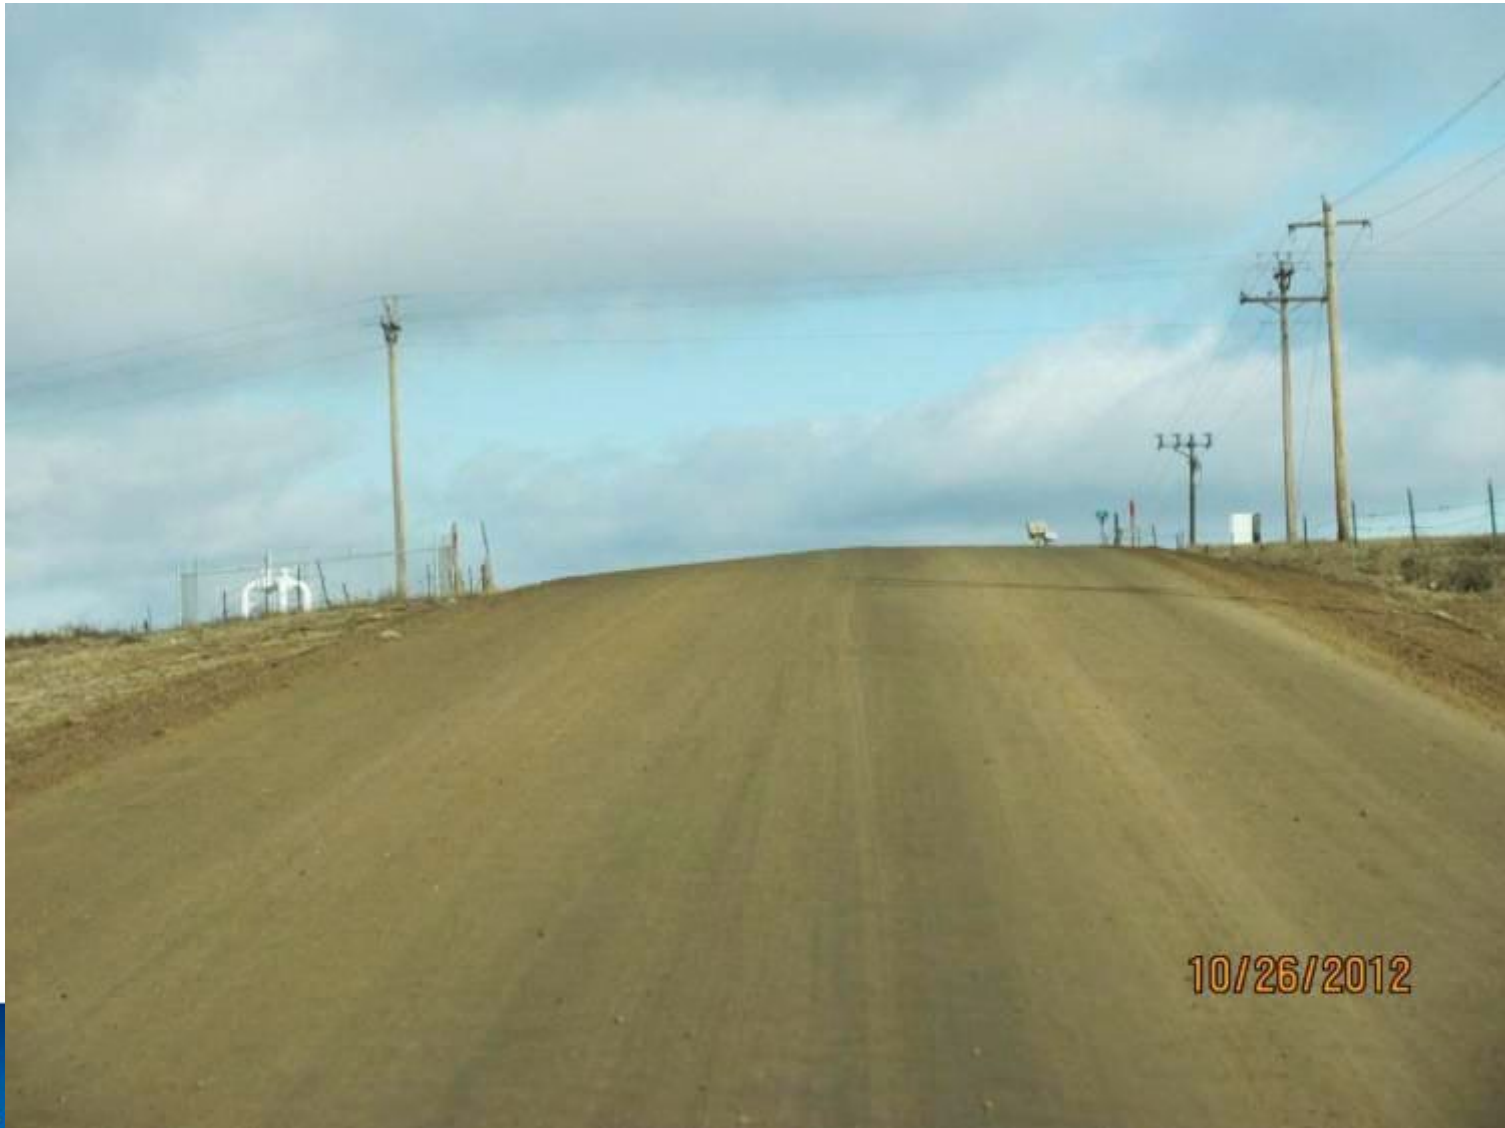
No significant loose aggregate and no corrugation even on 7% grade.

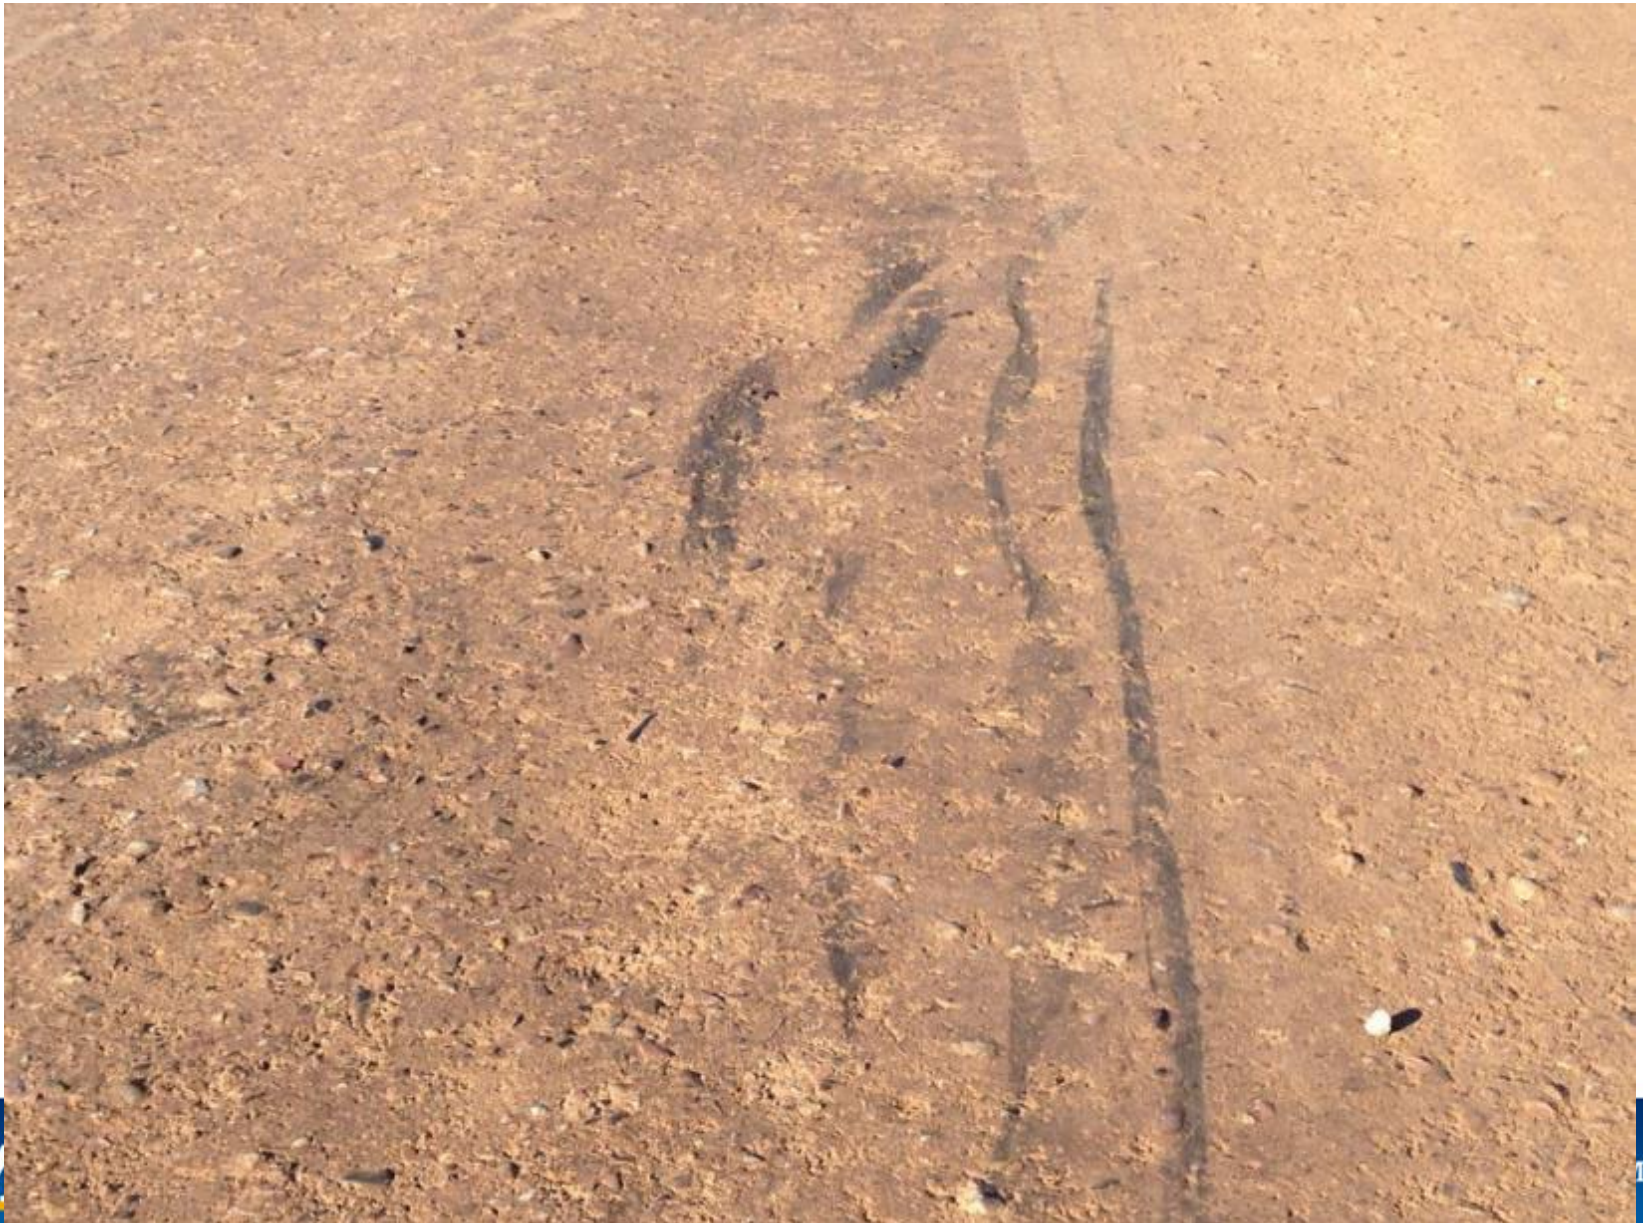
Skid marks from recent incident, 1 year later

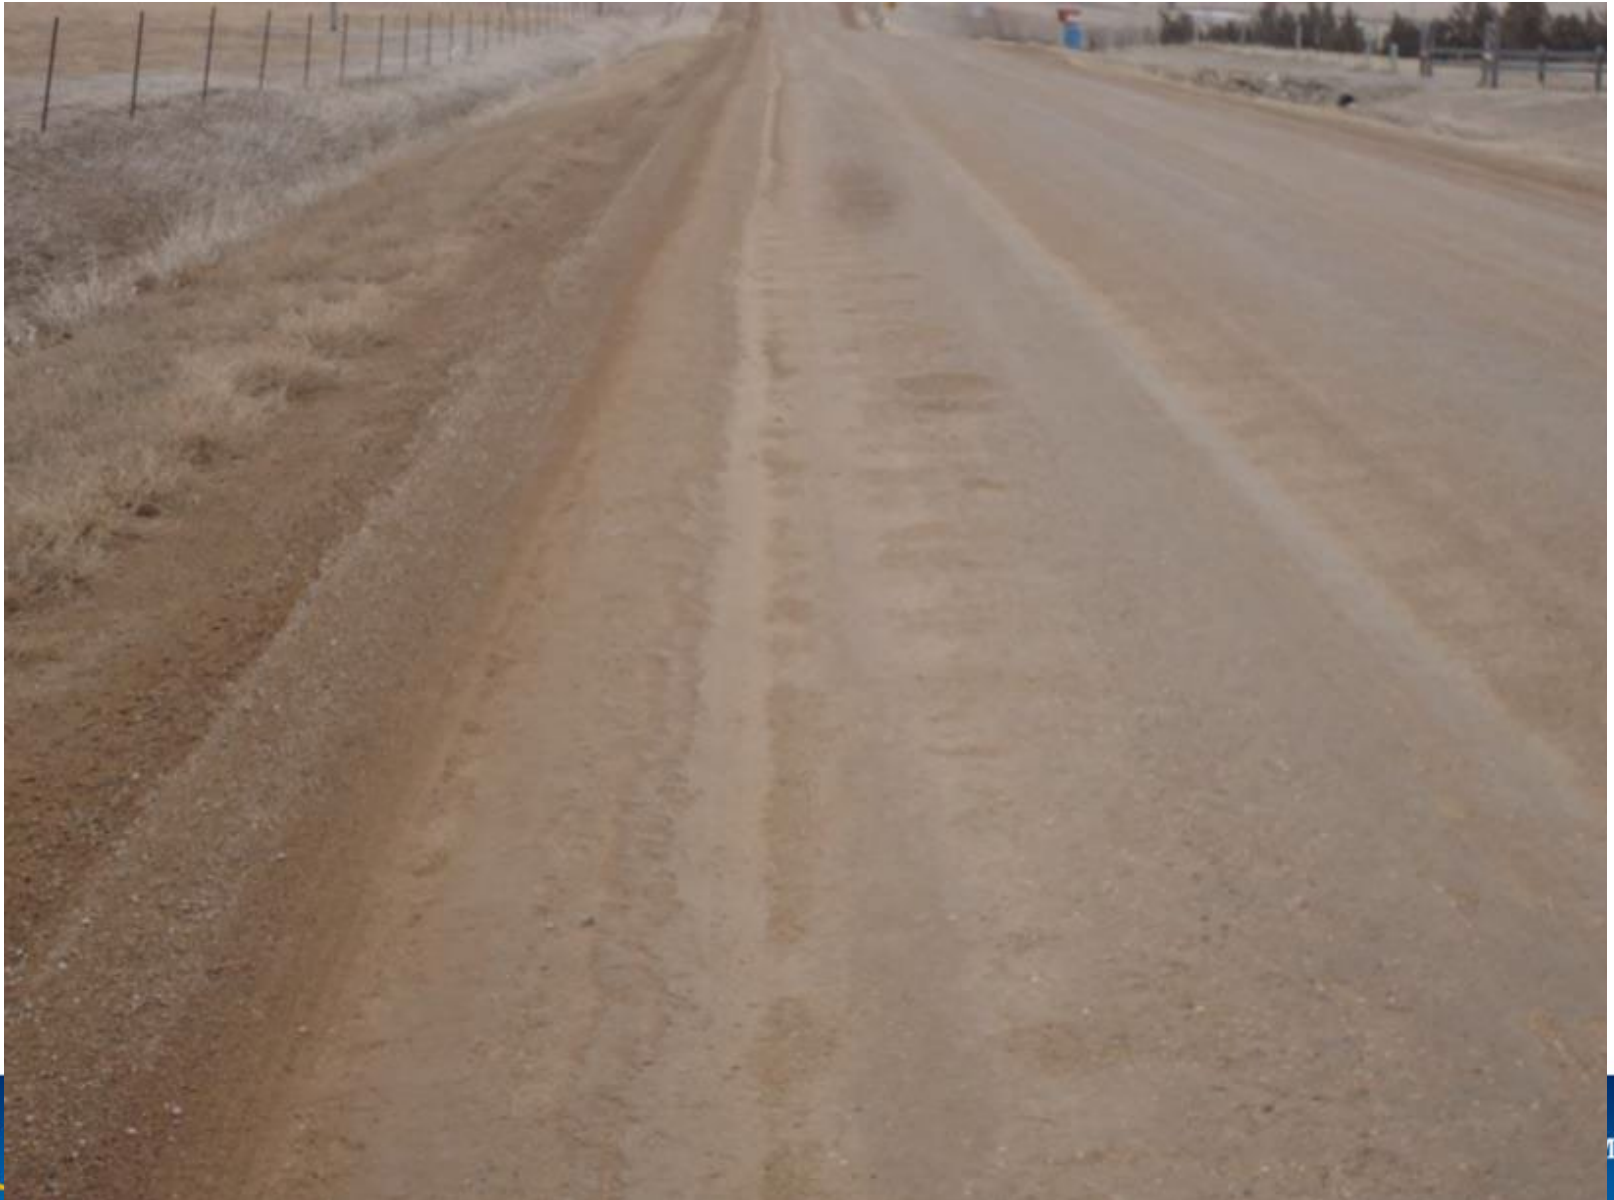
Same location – left shoulder

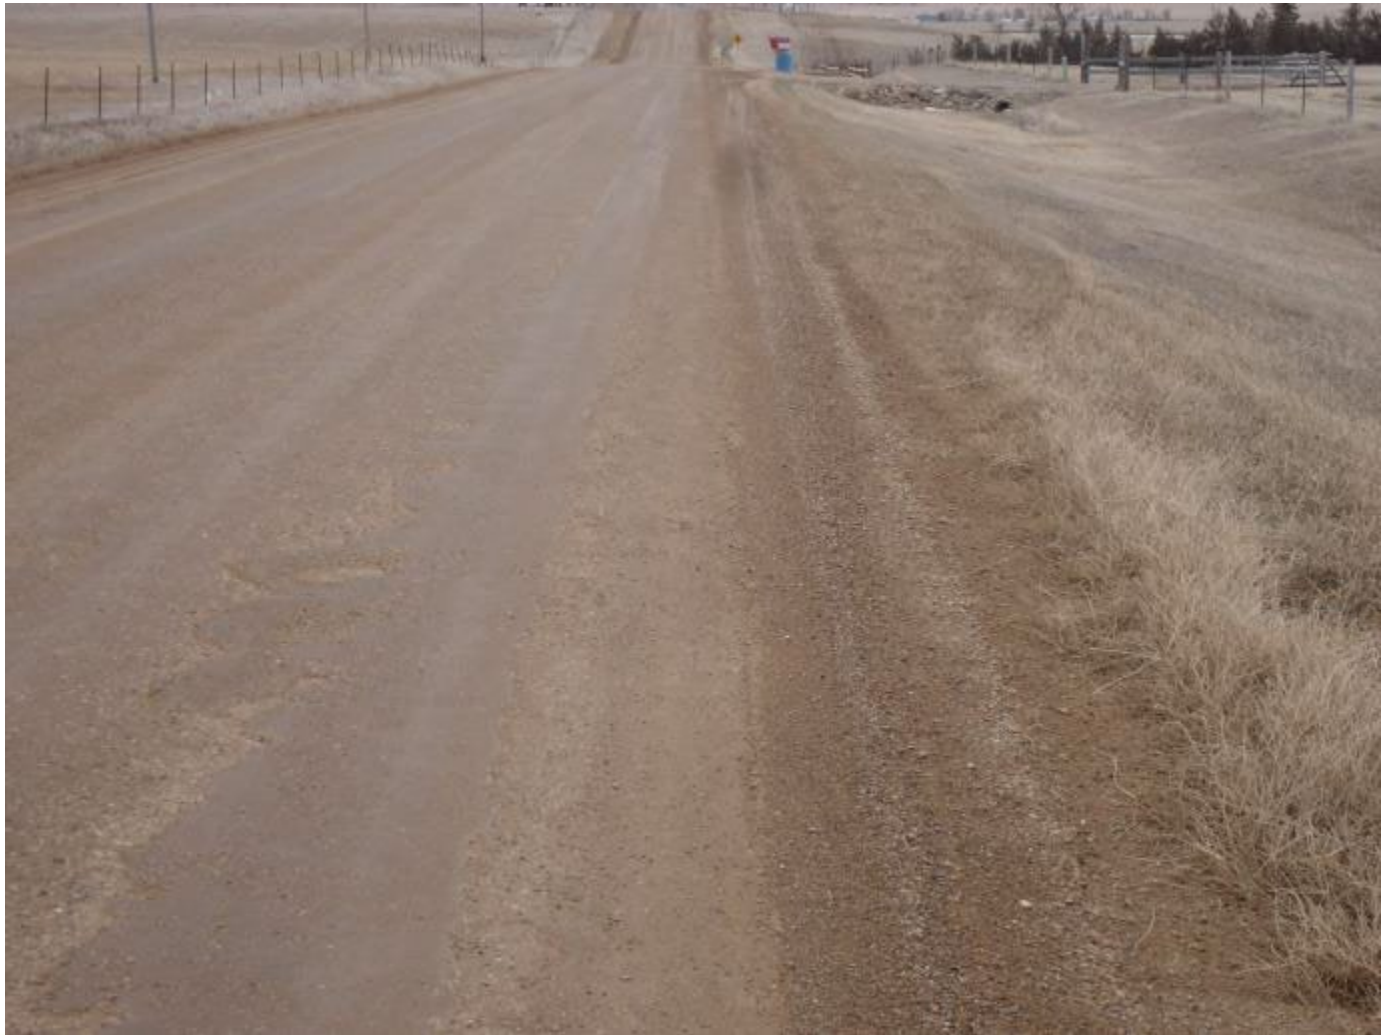
Same location – right shoulder
